## ENGINEERING REPORT

**November 12, 2025**

**RE: Construction Defect Assessment  
City of Fayetteville  
Fayetteville Fire Department New Sub-Station No. 4  
4210 Bragg Boulevard  
Fayetteville, North Carolina 28303  
ABS File Number: 900.25030**

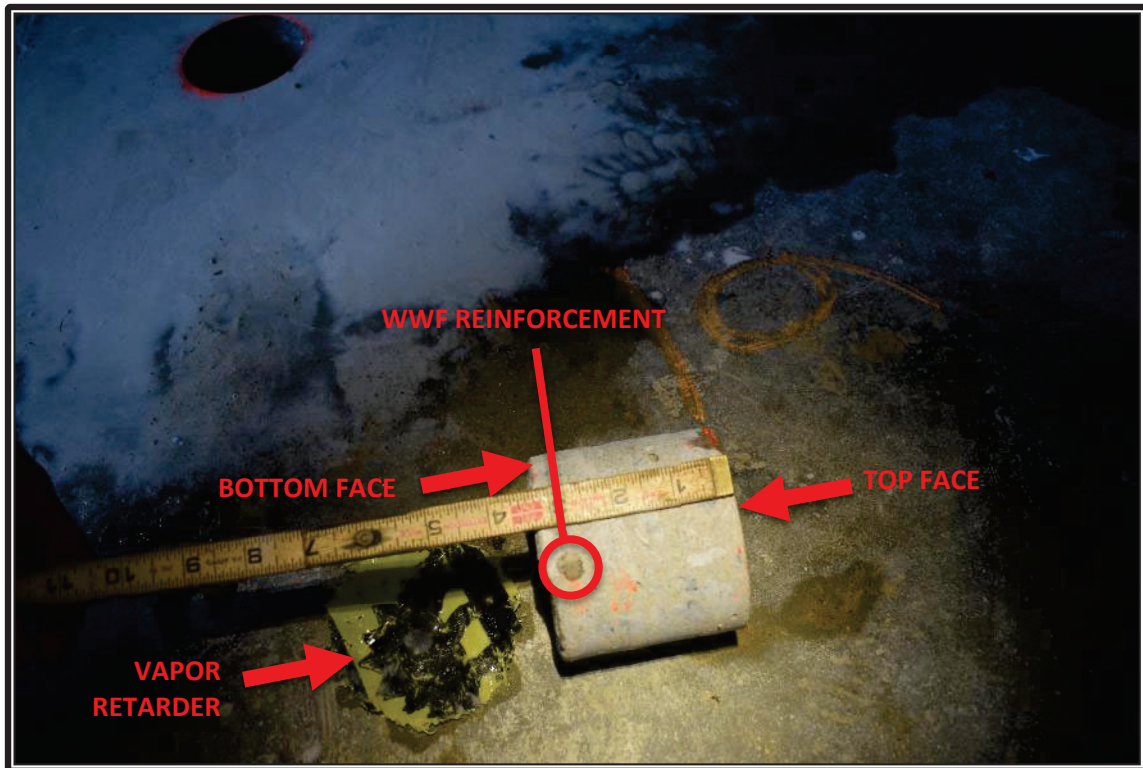
2. At each of the core drilling locations, a 10-mil vapor retarder was observed at the underside of the concrete slab above the stone base.
3. WWF was observed within each of the six (6) cores. Measured from the bottom of the slab core, the cover of the wire at three (3) of the cores measured approximately 1 inch; at the three (3) remaining cores, the cover of the wire measured approximately 1.25 inches, 0.75 inches, and 0.5 inches. The 4-inch diameter concrete cores each intersected one (1) parallel wire, indicating that the spacing of the welded wire fabric exceeded 4 inches. The specified WWF spacing was 6 inches.

**Photo 4:** View of concrete core measuring approximately 3.25 inches in depth, the location of a WWF wire, and vapor retarder.

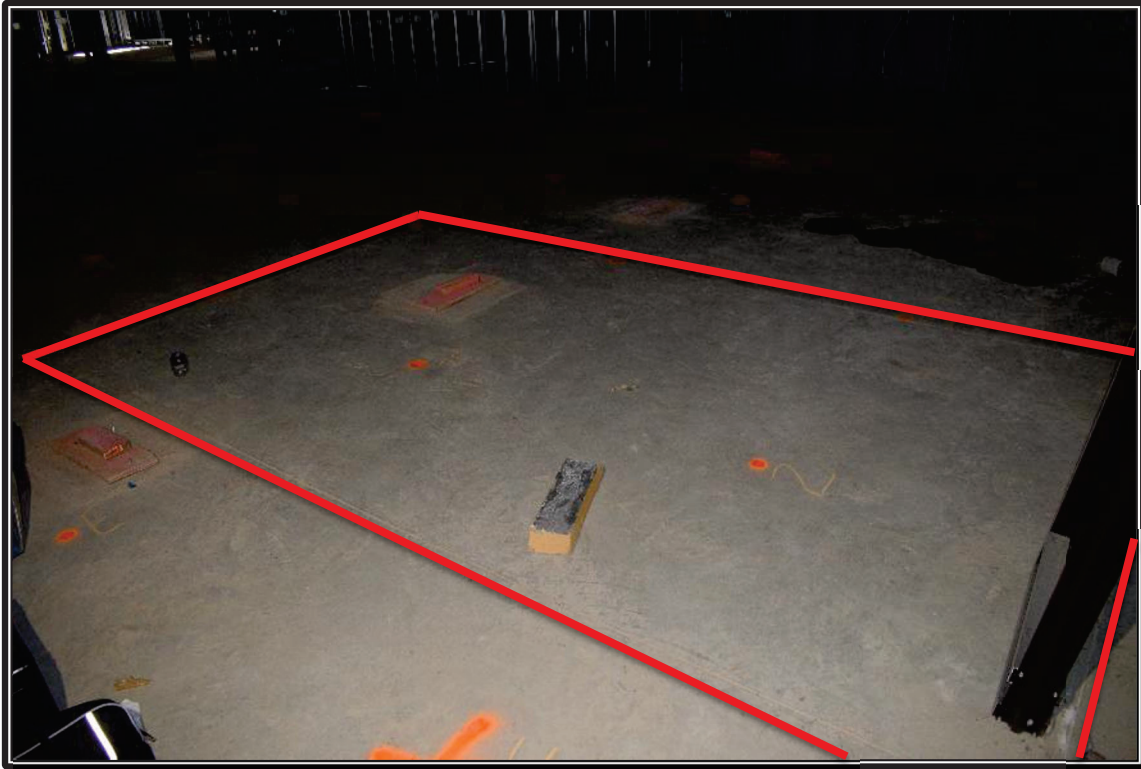
8. The sawcut control joints observed throughout the living area slab-on-ground were generally spaced at approximately 10 to 15 feet in both directions; however, the spacing of the joints varied in some areas.
9. In at least one (1) location, the length of the control joint panel was approximately double the width of the panel, resulting in an aspect ratio of approximately 2 to 1 (**Photo 5**).

The plans (Sheet 3.01) provide a detail for the construction of control joints in the slabs, but do not specify the location or spacing of the control joints. According to the "Construction Joint Layout" submittal, comments from T&V indicate that the maximum control joint spacing for the living area 4-inch slab-on-ground is 16 feet. According to ACI 360R-10 Section 6.1.3, the recommended control joint (referred to as a contraction joint in ACI 360R-10) spacing for a 4-inch typical concrete slab is approximately 11 feet; it also specifies that the maximum aspect ratio of any panel should be 1.5 to 1 and that L- and T-shaped panels should be avoided. It is ABS' opinion that the living area slab-on-ground control joints are generally spaced in accordance with the "Control Joint Layout" submittal and ACI 360R-10, but that some control joint panels exceed the limiting 1.5 to 1 aspect ratio specified in ACI 360R-10.

**Photo 5:** Representative view of a control joint panel with an aspect ratio of approximately 2 to 1 (outlined).

**ABS Recommendation:** It is ABS' opinion that areas of the interior concrete slab-on-ground that do not meet these requirements should be removed and replaced or modified to meet the requirements.

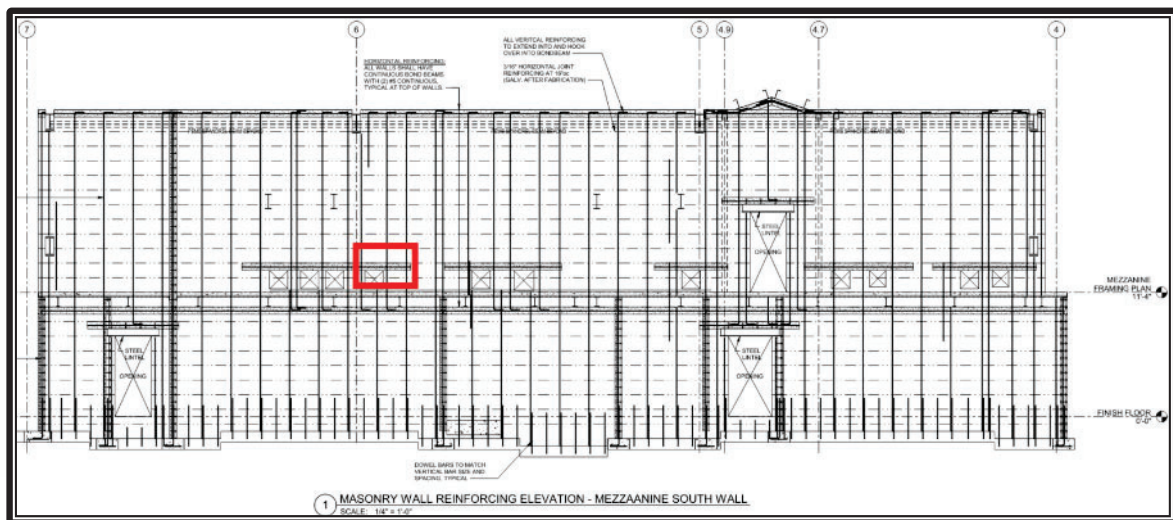
Test Area 1 was located at the full-height mezzanine wall within the living area and was tested from the south face of the wall (**Figure 4**). The plans (Sheet 3.59) indicate that Test Area 1 should have included a bond beam at the top of the adjacent series of openings, jamb reinforcement at each opening, and typical wall reinforcement. Note that RFI #53 indicates that within the area below the HVAC openings at Test Area 1, cells should be fully grouted.

**Figure 4:** CMU wall elevation showing the approximate location of Test Area 1 (outlined) (cropped plan courtesy of T&V).

10. The openings at Test Area 1 were positioned such that the top of the openings were located midway through a CMU course. As a result, it appeared that the bond beam at Test Area 1 was constructed above the partial CMU course. Other openings within the same wall were located with the top of the opening level with the top of a full CMU course.
11. At the bond beam above the openings, cells appeared to contain reinforcement and be grouted.

**ABS Recommendation:** Because of the extent of improperly constructed CMU walls identified in F&R's March 11, 2024, letter and/or during ABS' site visit, including at multiple critical structural components, it is ABS' opinion that the interior and exterior CMU walls should be removed and reconstructed.

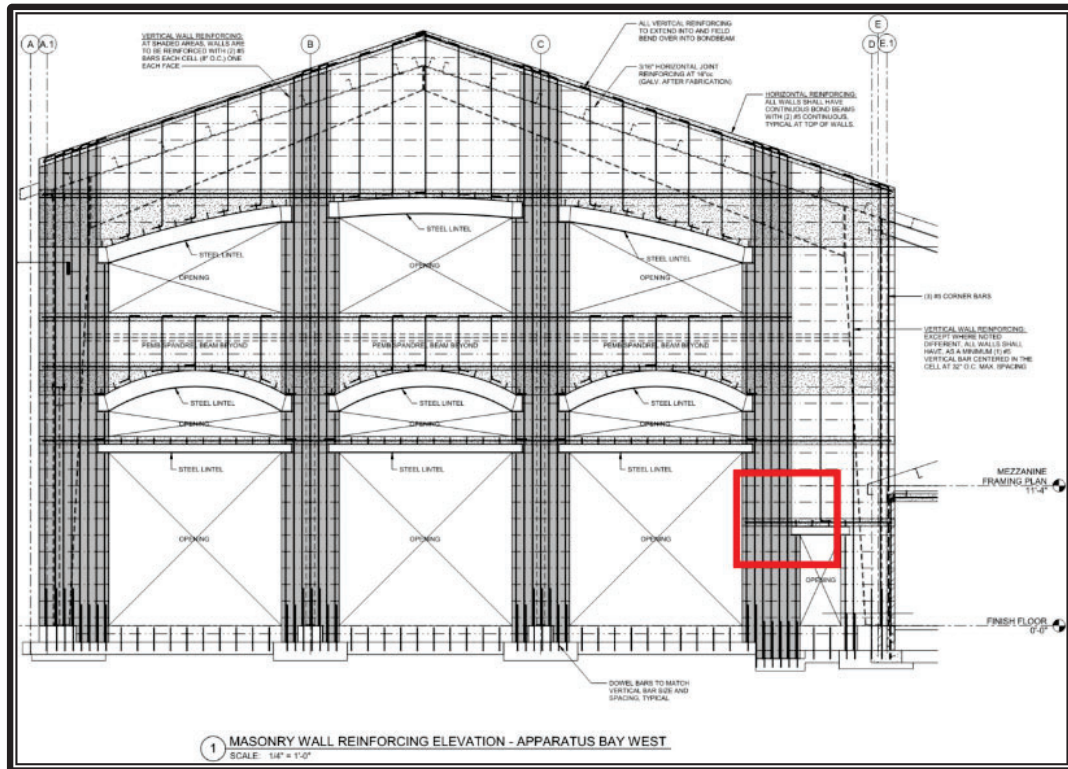
Test Area 3 was located at the west apparatus bay wall and was tested from the east face of the wall (**Figure 6**). The plans (Sheet 3.56) indicate that Test Area 3 should have included a bond beam at the top of the adjacent opening, jamb and bearing reinforcement at each opening, reinforcement along the control joint (not shown on the plans), and typical wall reinforcement.

**Figure 6:** CMU wall elevation showing the approximate location of Test Area 3 (outlined) (cropped plan courtesy of T&V).

19. The bond beam located at the top of the adjacent opening appeared to contain reinforcement and be grouted. It appears that the bond beam reinforcement ends at the control joint located adjacent to the opening.
20. The cells along the opening's jamb and bearing locations appeared to contain reinforcement and be grouted.
21. The cells along either side of the control joint appeared to contain reinforcement and be grouted.
22. Grout and reinforcement observed in the field of the wall was consistent with expected typical wall reinforcement.

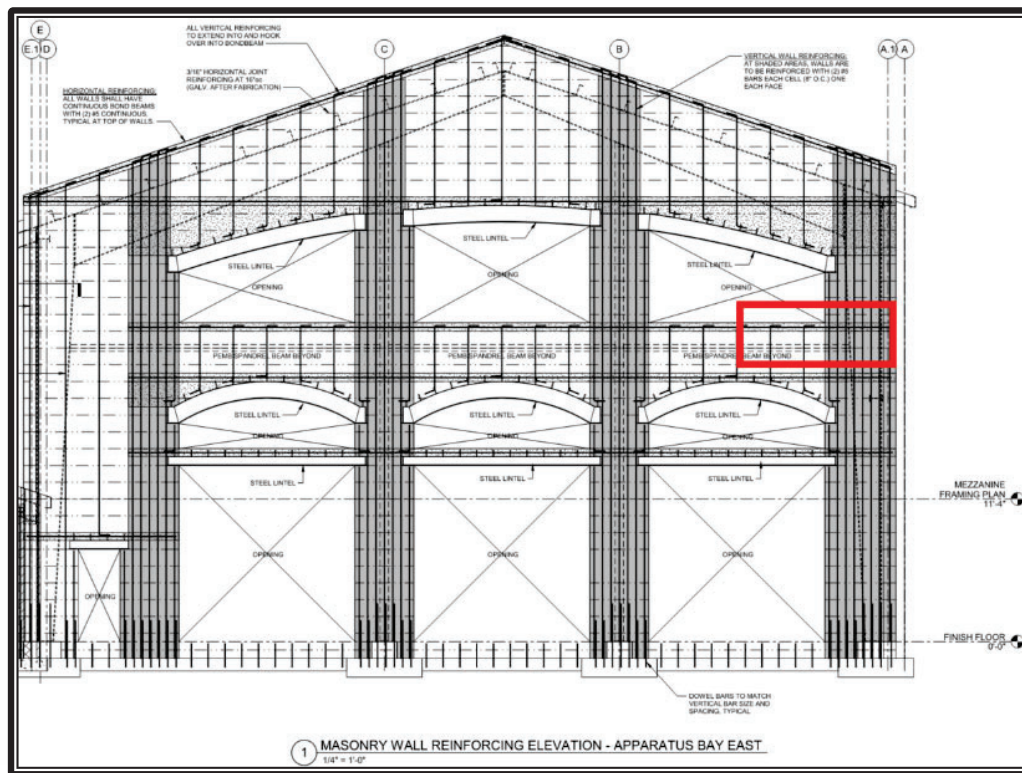
Test Area 4 was located at the east apparatus bay wall and was tested from the west face of the wall (**Figure 7**). The plans (Sheet 3.55) indicate that Test Area 4 should have included a bond beam at the bottom of the opening, jamb and bearing reinforcement at the opening, corner reinforcement, and typical wall reinforcement.

**Figure 7:** CMU wall elevation showing the approximate location of Test Area 4 (outlined) (cropped plan courtesy of T&V).

23. The bond beam along the bottom of the opening appeared to contain reinforcement and be grouted. Note that the eddy current sensor could not identify differences between continuous bond beam reinforcement and typical vertical wall reinforcement bent and embedded into the bond beam.
24. Where the bond beam is continuous to the corner of the CMU wall, investigation of reinforcement and grout was obstructed by the PEMB structural steel. Reinforcement at the corner could not be verified.

25. The cells along the opening's jamb and bearing locations appeared to contain reinforcement and be grouted.
26. Grout and reinforcement observed in the field of the wall were consistent with expected typical wall reinforcement.

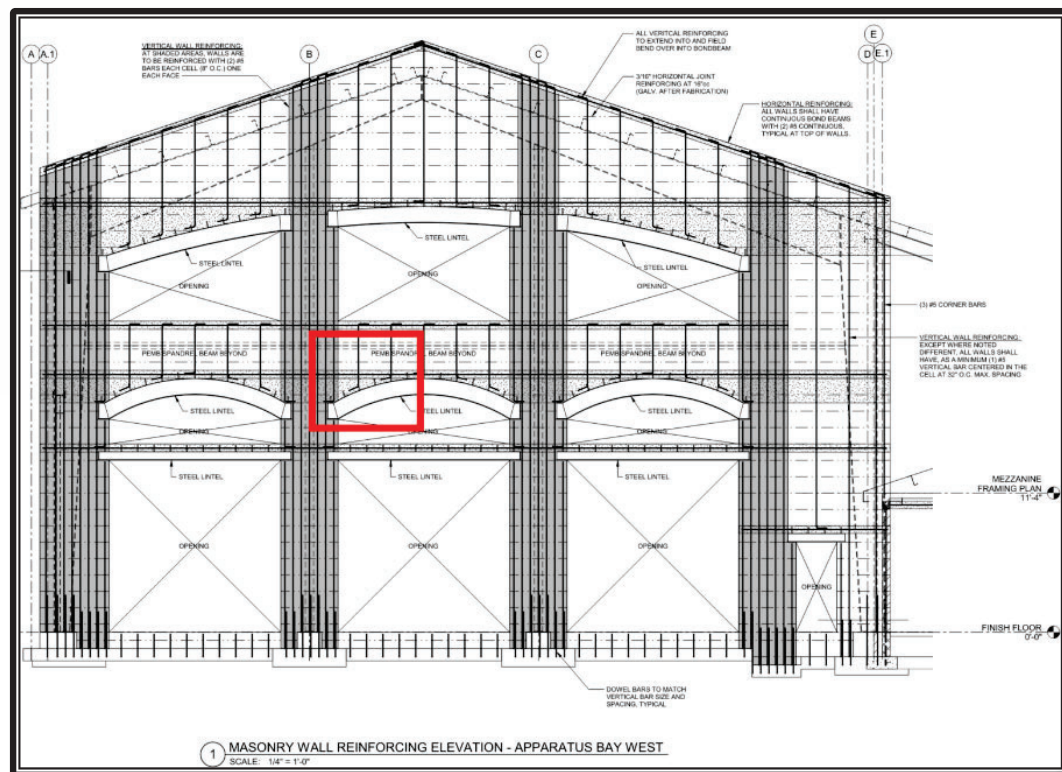
Test Area 5 was located at the west apparatus bay wall and was tested from the east face of the wall (**Figure 8**). The plans (Sheet 3.56) indicate that Test Area 5 should have included a bond beam at the top of the opening, jamb and bearing reinforcement at the opening, and typical wall reinforcement.

**Figure 8:** CMU wall elevation showing the approximate location of Test Area 5 (outlined) (cropped plan courtesy of T&V).

27. The bond beam along the top of the opening appeared to contain reinforcement and be grouted. Note that ABS' investigation could not identify differences between continuous bond beam reinforcement and typical vertical wall reinforcement bent and embedded into the bond beam. Additionally, studs from the steel lintel may have interfered with the observed reinforcement within the bond beam.
28. The cells along the opening's jamb and bearing locations appeared to contain reinforcement and be grouted.
29. Grout and reinforcement observed in the field of the wall were consistent with expected typical wall reinforcement.

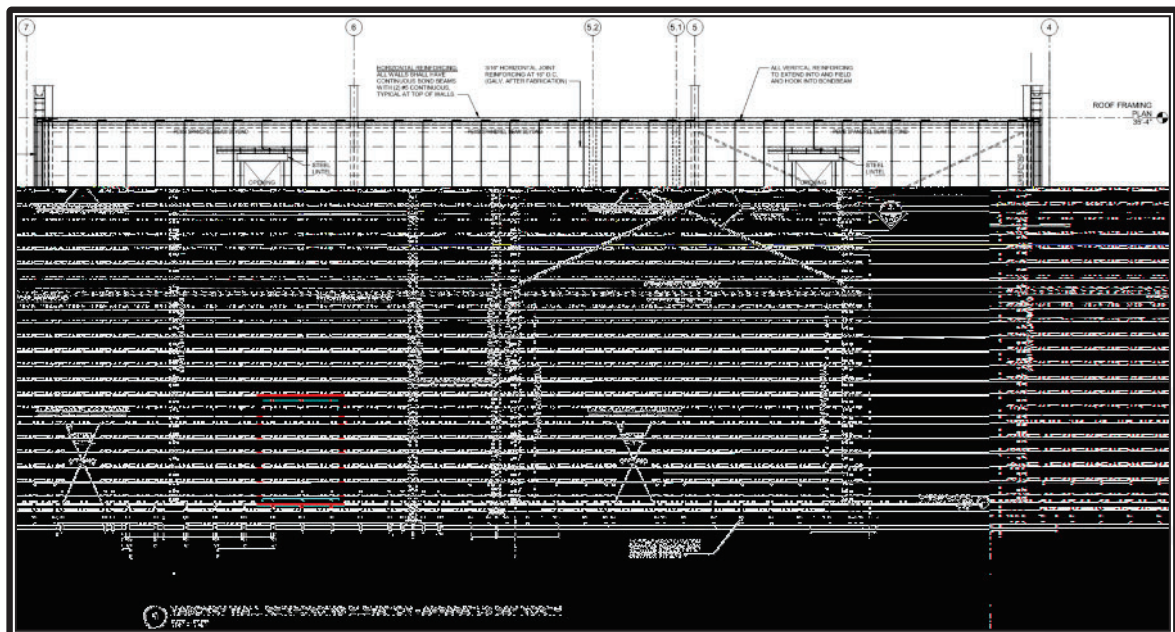
Test Area 6 was located at the north apparatus bay wall and was tested from the south face of the wall (**Figure 9**). The plans (Sheet 3.57) indicate that Test Area 6 should have included joint reinforcement (not shown on the plans) and typical wall reinforcement.

**Figure 9:** CMU wall elevation showing the approximate location of Test Area 6 (outlined) (cropped plan courtesy of T&V).

30. The cells along either side of the control joint appeared to contain reinforcement and be grouted.
31. Grout and reinforcement observed in the field of the wall were consistent with expected typical wall reinforcement.
32. At the control joint, ladder reinforcement within the mortar joints was observed between every other course (16 inch spacing).

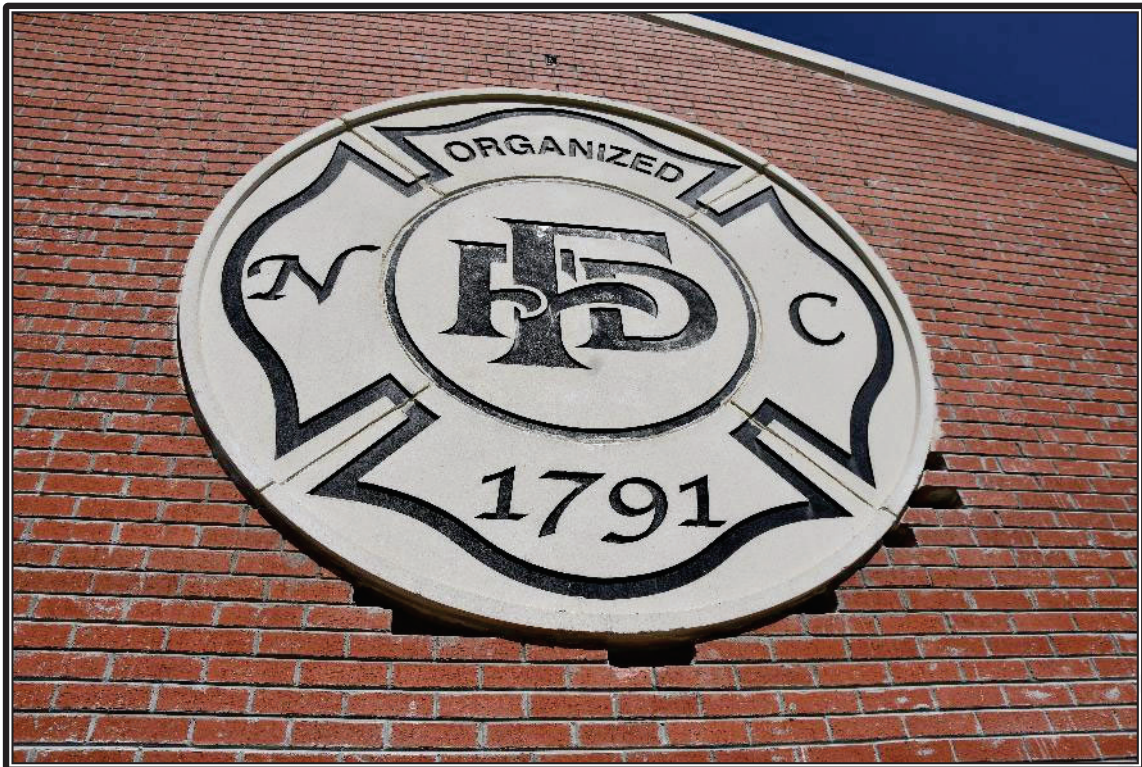
33. The cast stone medallion at Test Area 1 was comprised of five (5) individual sections of cast stone: one (1) circular section at the center surrounded by four (4) sections of a ring (**Photo 6**).

If the anchoring of the sector sections depicted on the shop drawings was used for installation of the ring sections at Test Area 1, missing anchors were identified. Due to the limited access and visibility, all anchors could not be identified; however, ABS was able to confirm that no anchors were installed along the bottom and outer edge of the lower ring section. The equivalent sector section from the shop drawings requires three anchors along this edge. It is ABS' opinion that the anchoring of at least one (1) section of the large cast stone medallions is not in compliance with the exterior cast stone shop drawings.

**Photo 6:** View of the cast stone medallion at Test Area 1.

**ABS Recommendation:** ABS recommends that the exterior cast stone as-built conditions identified during ABS' site visit be reviewed by the cast stone manufacturer and EOR. It is ABS' opinion that if the as-built condition of the cast stone is approved by the cast stone manufacturer and EOR, no further action is required; however, if modifications to the attachment method specified by the cast stone manufacturer and EOR are required, removal of the cast stone and/or brick veneer may be necessary.

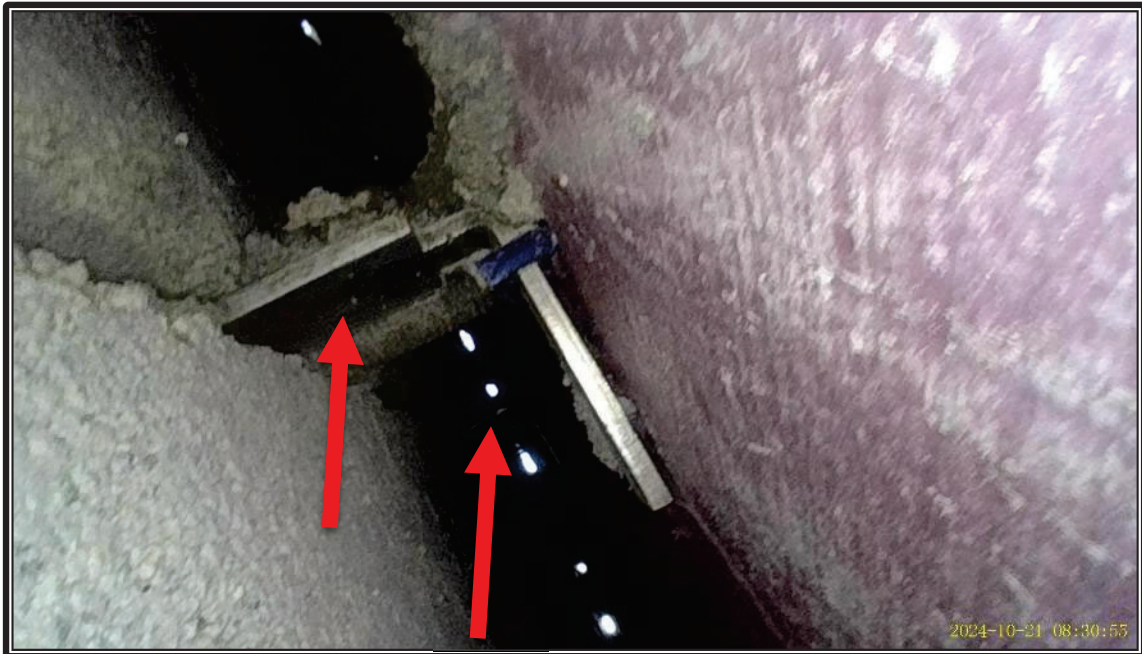
35. At the joint between the lower ring section and the right ring sections, at least two (2) anchors were observed (**Photo 7**). The depth of the anchor flange into the cast stone could not be determined.

**Photo 7:** Representative view of the anchors at Test Area 1 (arrows).

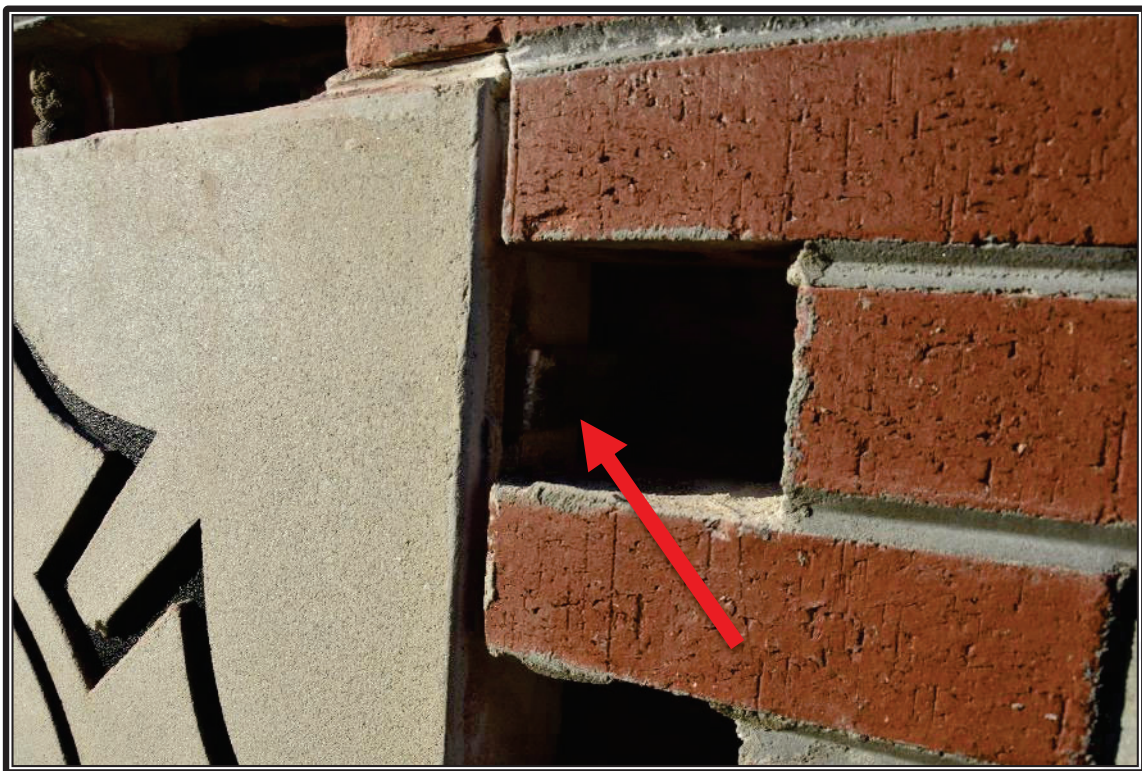
41. The right edge of the cast stone was observed in its entirety by means of removal of two (2) partial brick veneer units and use of the articulating borescope. Along this edge, two (2) anchors holding the cast stone were observed (**Photo 8**). The depth of the anchor flange into the cast stone measured approximately 1.5 inches from the front face. Anchoring along the left edge of the medallion could not be verified without additional brick removal.

**Photo 8:** Representative view of the anchor at Test Area 2 (arrow).

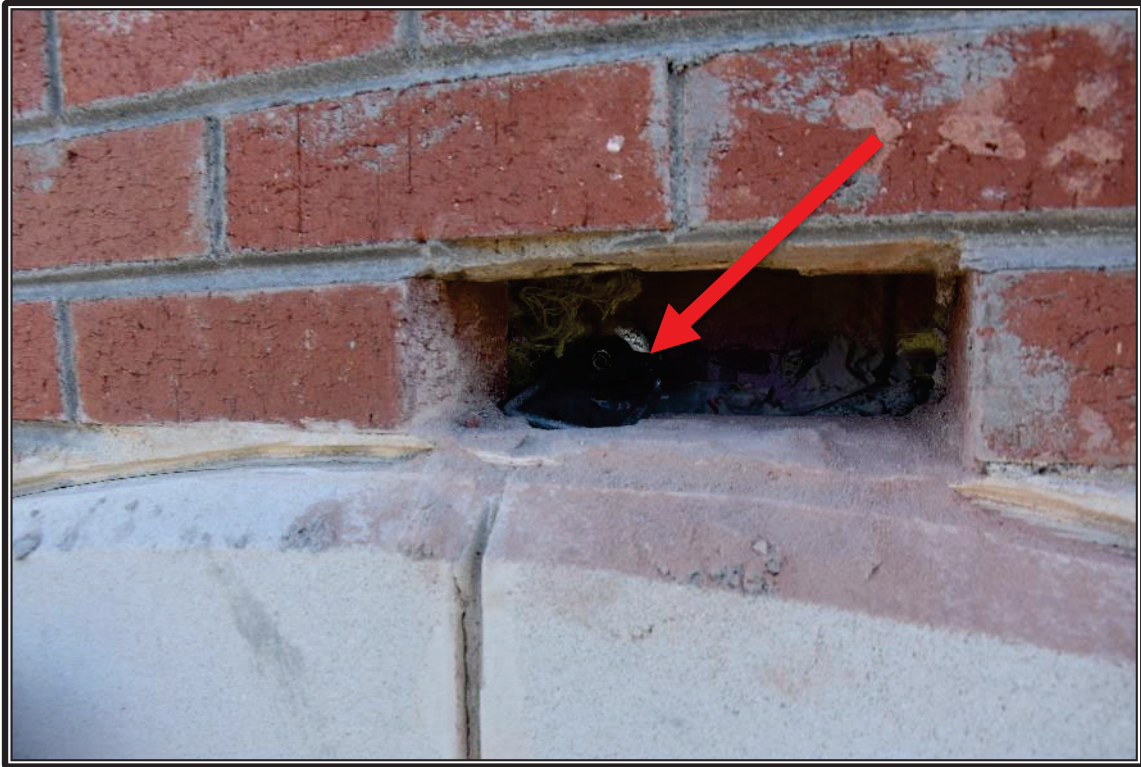
The cast stone accents at the jamb were installed with anchors between adjacent sections; however, no anchor was observed at the section of cast stone at the top of the jamb. It is ABS' opinion that the anchoring of the cast stone at this location is not in compliance with the exterior cast stone shop drawings.

**Photo 9:** Representative view of a masonry wall tie at the head of the window opening at Test Area 3 (arrow).

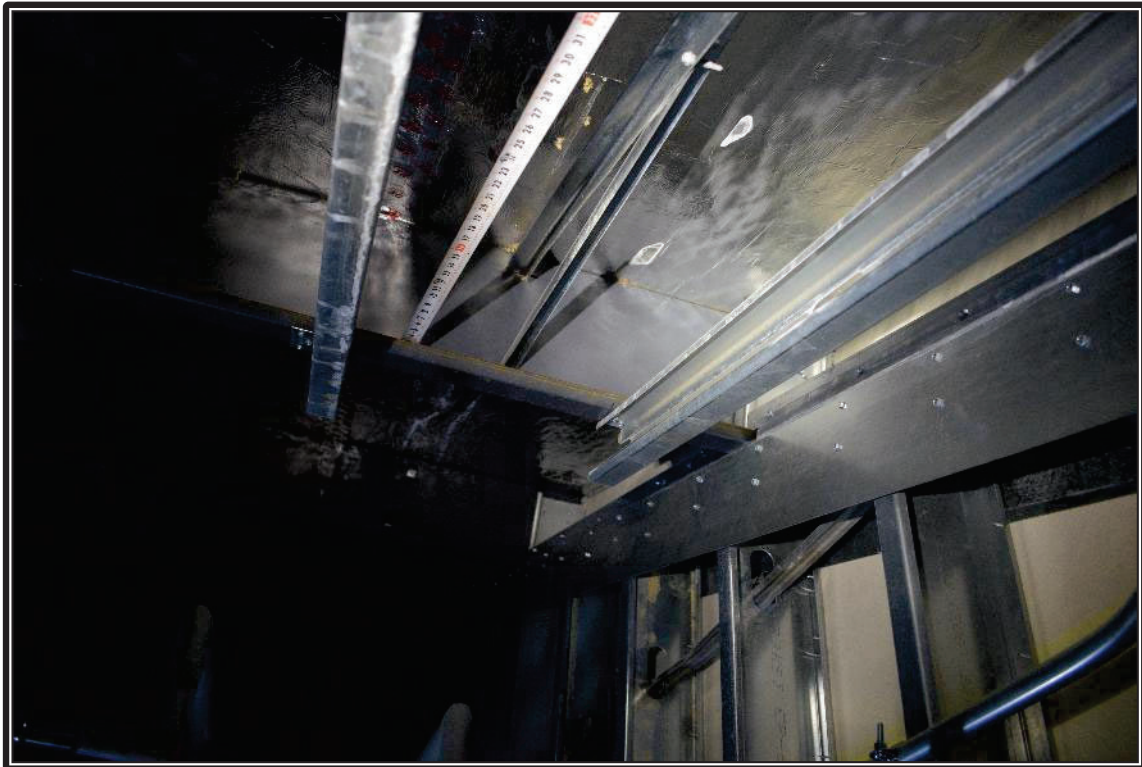
47. Flat metal straps were installed over pre-manufactured slip tracks (**Photo 10**). This condition appears to be an attempt to create a deeper slip track.
48. At many locations, the light-gauge metal studs had little to no clearance to the slip track, creating a condition that will allow little to no movement (**Photo 11**).
49. Bridging was missing within 12 inches of the slip track on multiple light-gauge metal walls (**Photo 12**).

**Photo 10:** Representative view of the metal strapping at the slip track.

It is ABS' opinion that all non-complying components that may also be compromised due to long-term exposure to the elements should be repaired or replaced to be in compliance with the approved architectural and structural plans.

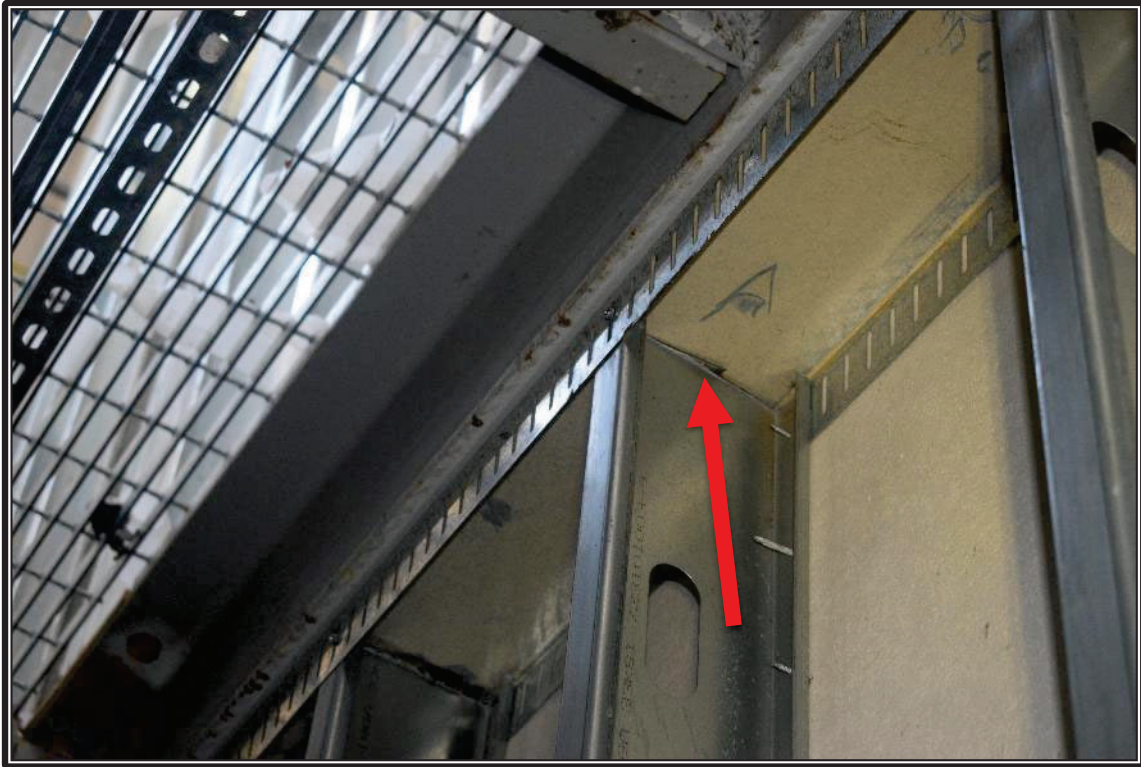
**Photo 11:** Representative view of a light-gauge metal stud with inadequate clearance at the slip track (arrow).

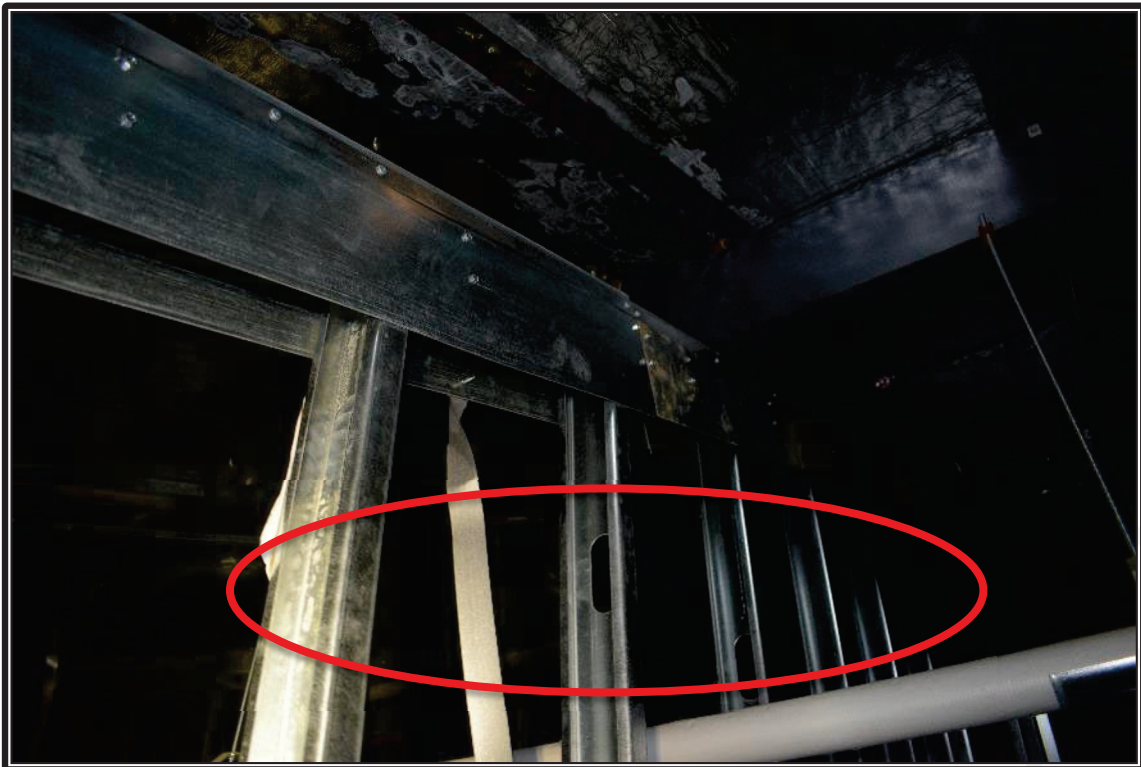
**Photo 12:** Representative view of the missing light-gauge metal wall bridging (oval).

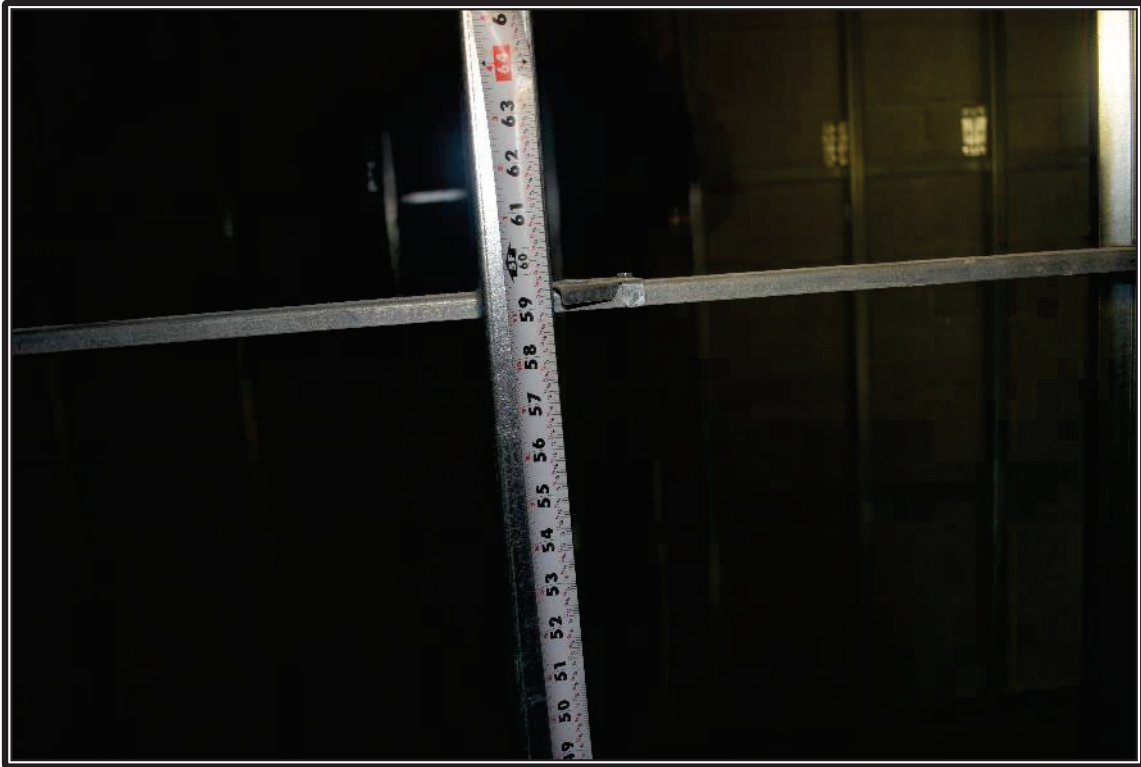
50. The first row of light-gauge metal wall bridging was measured at 59 inches above the concrete slab and 72 inches on center above that (**Photo 13**). Detail 3 on Sheet 3.04 indicates a 48-inch maximum distance to the first row of bridging above the concrete slab.
51. At the arch above window openings, the upper metal track was shimmed with gypsum wallboard (GWB) at multiple locations (**Photo 14**). No box header was observed over these openings as required on Sheet 3.04 (**Photo 15**).

**Photo 13:** Representative view of the measured distance to the first row of bridging above the concrete slab.

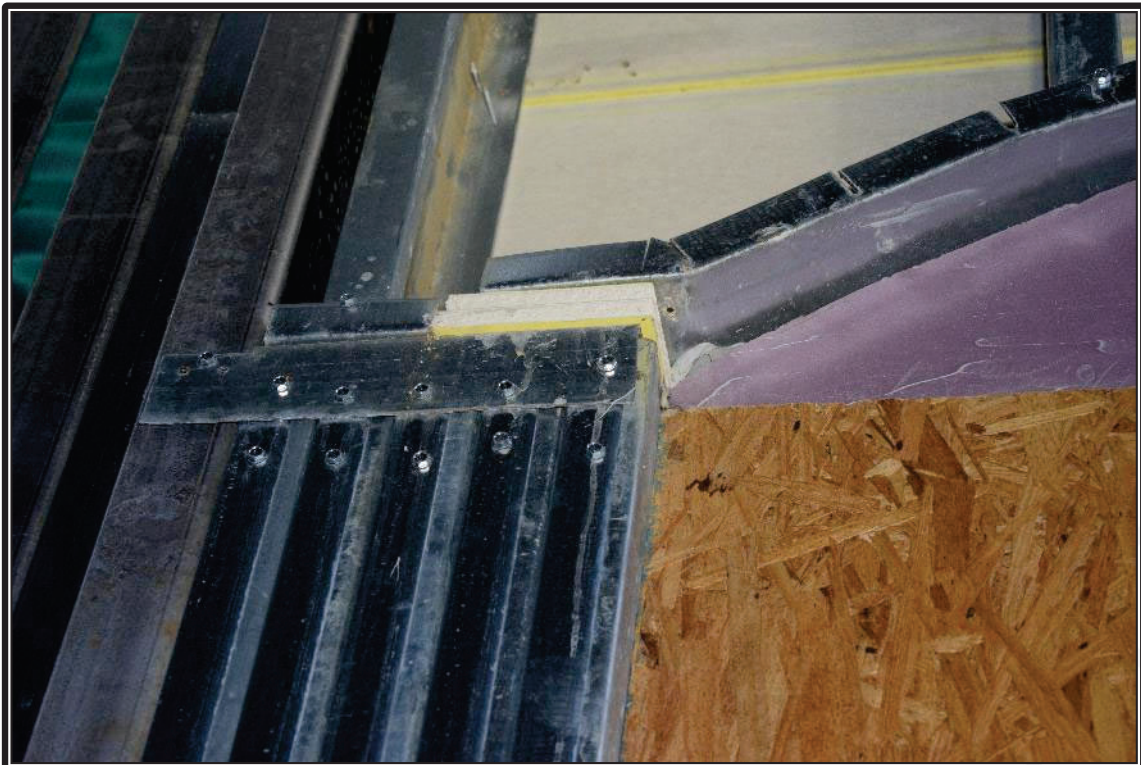
**Photo 14:** Representative view of GWB used as shims between the arched track and jack studs (arrow).

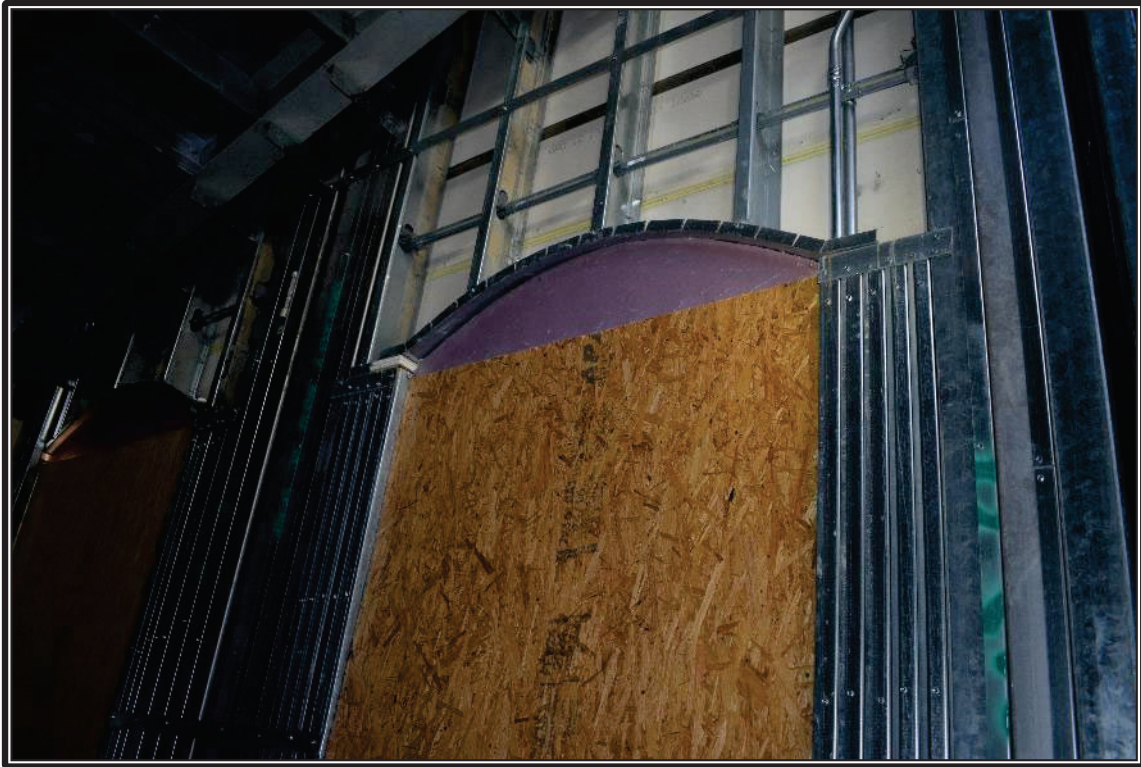
**Photo 15:** Representative view of an arched opening with no header.

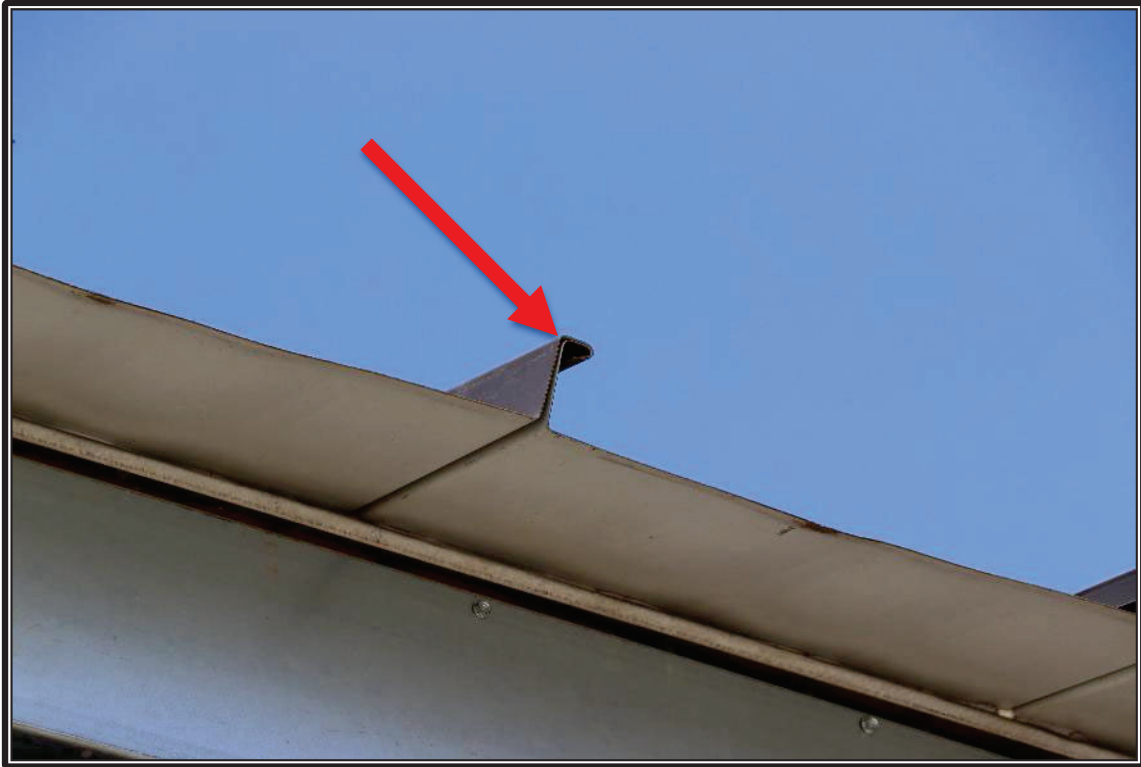
**Photo 16:** Representative view of a 90-degree single roll (1 phase) standing seam metal roof panel (arrow).

**ABS Recommendation:** Because of the extent of improper installation of the roof assembly identified during ABS' site visit and incomplete roof construction resulting in multiple points of entry for water intrusion, in addition to components now compromised due to long-term exposure to the elements, it is ABS' opinion that the entire roof assembly should be removed and replaced.

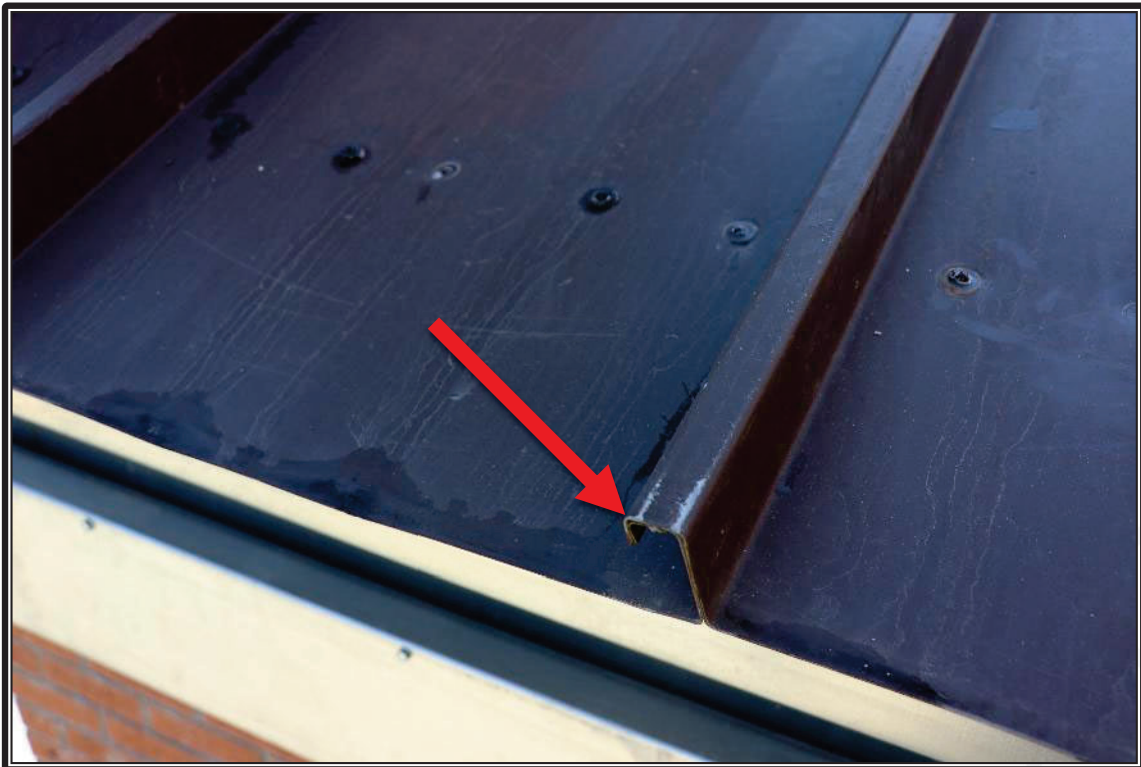
**Photo 17:** Representative view of an unseamed standing seam metal roof panel (arrow).

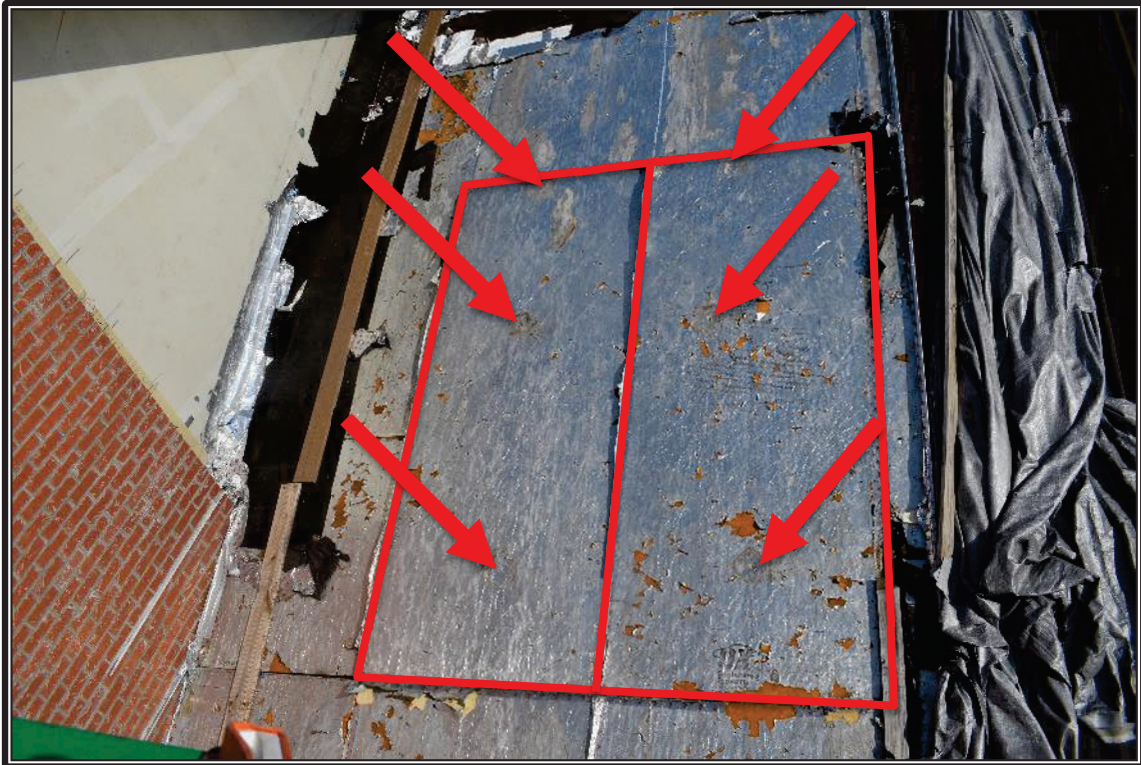
57. The rigid insulation boards were fastened to the roof structure with 6-inch self-tapping screws spaced in accordance with the purlin spacing (**Photo 18**). Each insulation board generally exhibited 2 or 3 fasteners. The 6-inch screws fastened both layers of insulation to the roof. Each screw was partially held in place by 5-inch by 5-inch light-gauge metal plates located at the top of the upper layer of insulation. At most observed locations, the metal plate was covered by a second metal plate of the same size, which was fastened to the bottom disc with a small screw. Where the upper insulation boards were temporarily removed by ABS, no fasteners at the bottom layer of insulation were observed.

**Photo 18:** Representative view of fastener locations installed through the upper two (2) rigid insulation boards (temporarily removed by ABS) (arrows).

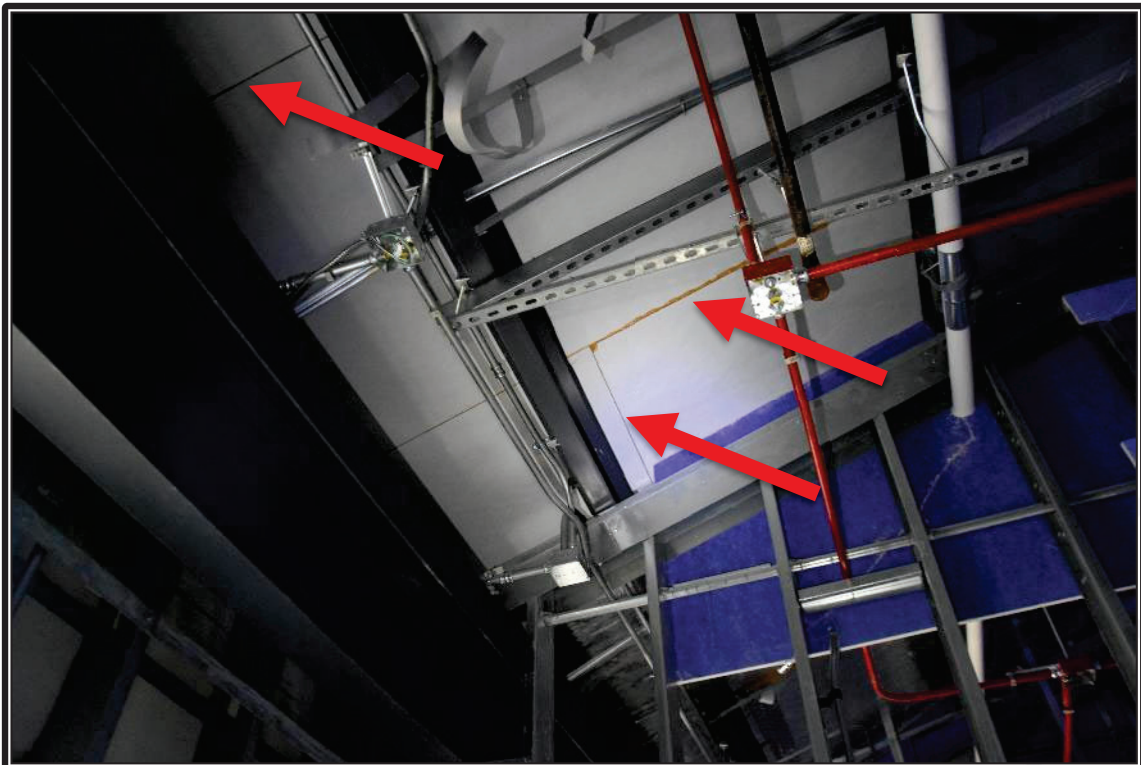
**Photo 19:** Representative view of seams with no tape or closure strip (arrows).

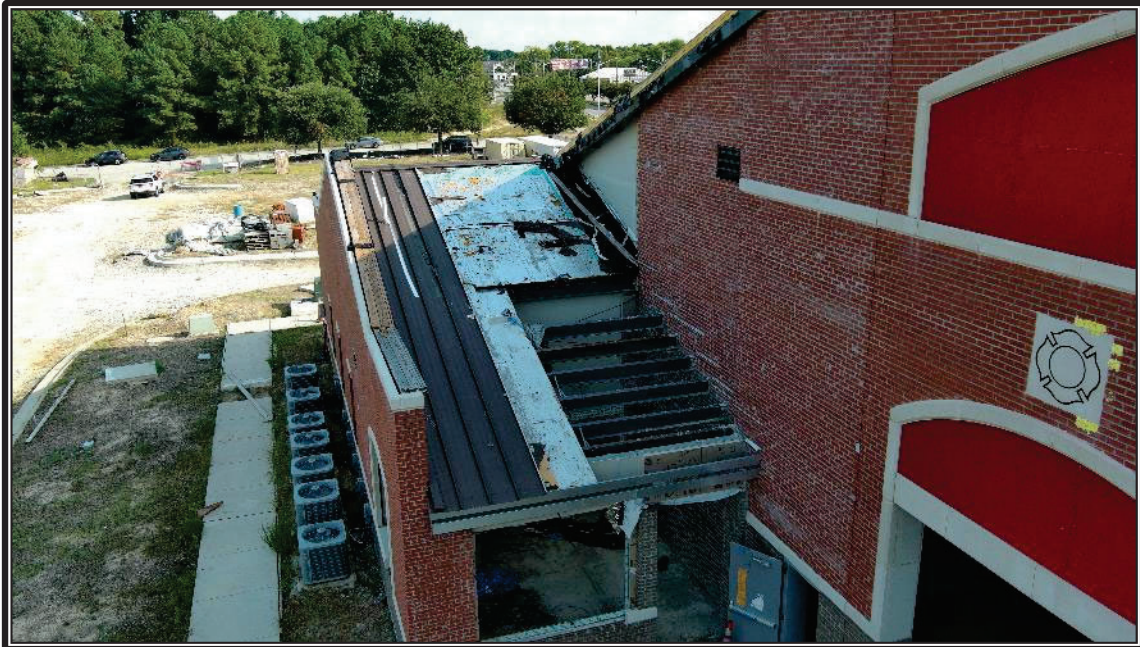
**Photo 20:** Representative view of deteriorated roof assembly materials at a section of incomplete roof.
