## ENGINEERING REPORT

**November 12, 2025**

**RE: Construction Defect Assessment  
City of Fayetteville  
Fayetteville Fire Department New Sub-Station No. 4  
4210 Bragg Boulevard  
Fayetteville, North Carolina 28303  
ABS File Number: 900.25030**

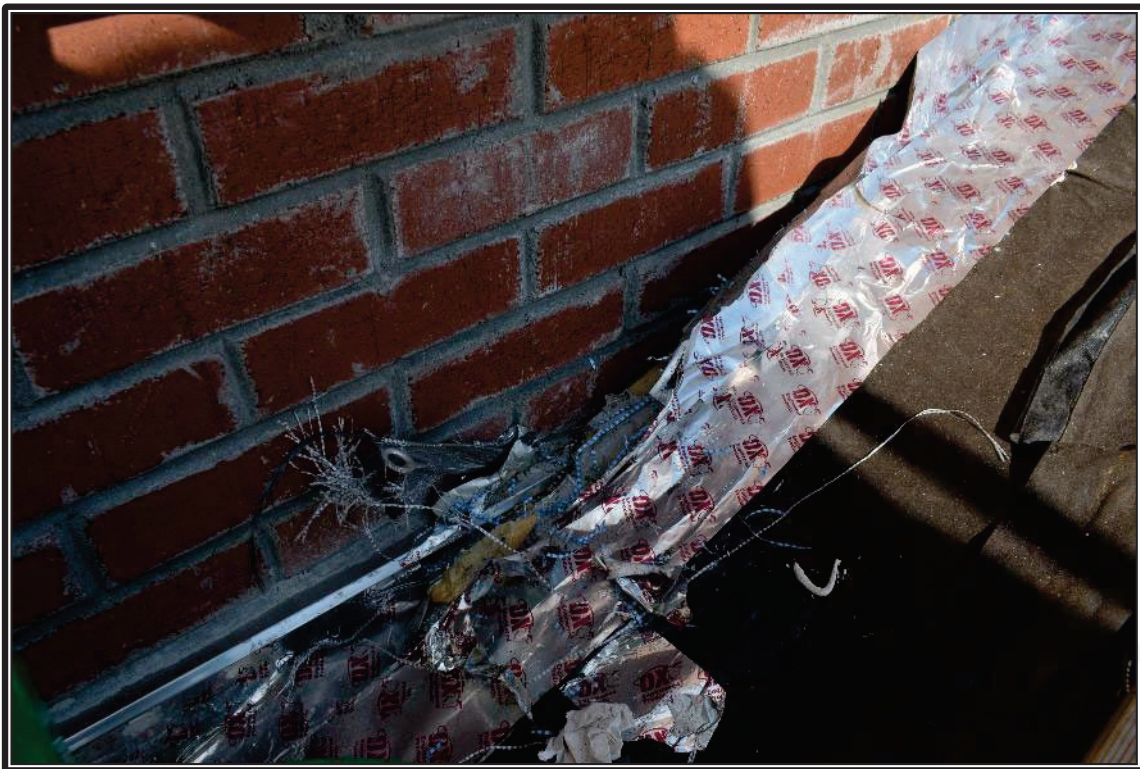
**Photo 21:** Representative view of through-wall flashing penetrating the roof insulation.

**ABS Recommendation:** Because of the extent of improper installation of the roof assembly identified during ABS' site visit and incomplete roof construction resulting in multiple points of entry for water intrusion, in addition to components now compromised due to long-term exposure to the elements, it is ABS' opinion that the entire roof assembly should be removed and replaced.

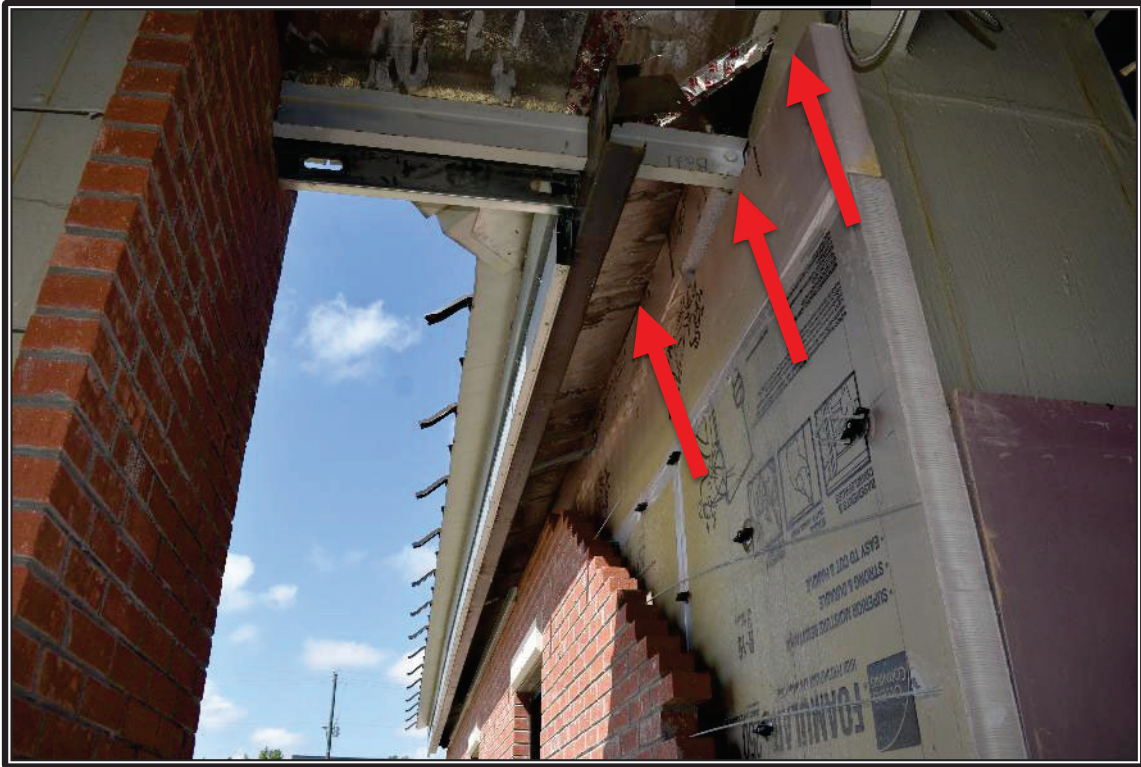
**Photo 22:** Representative view of missing spray foam insulation at the roof-to-exterior-wall interface (arrows).

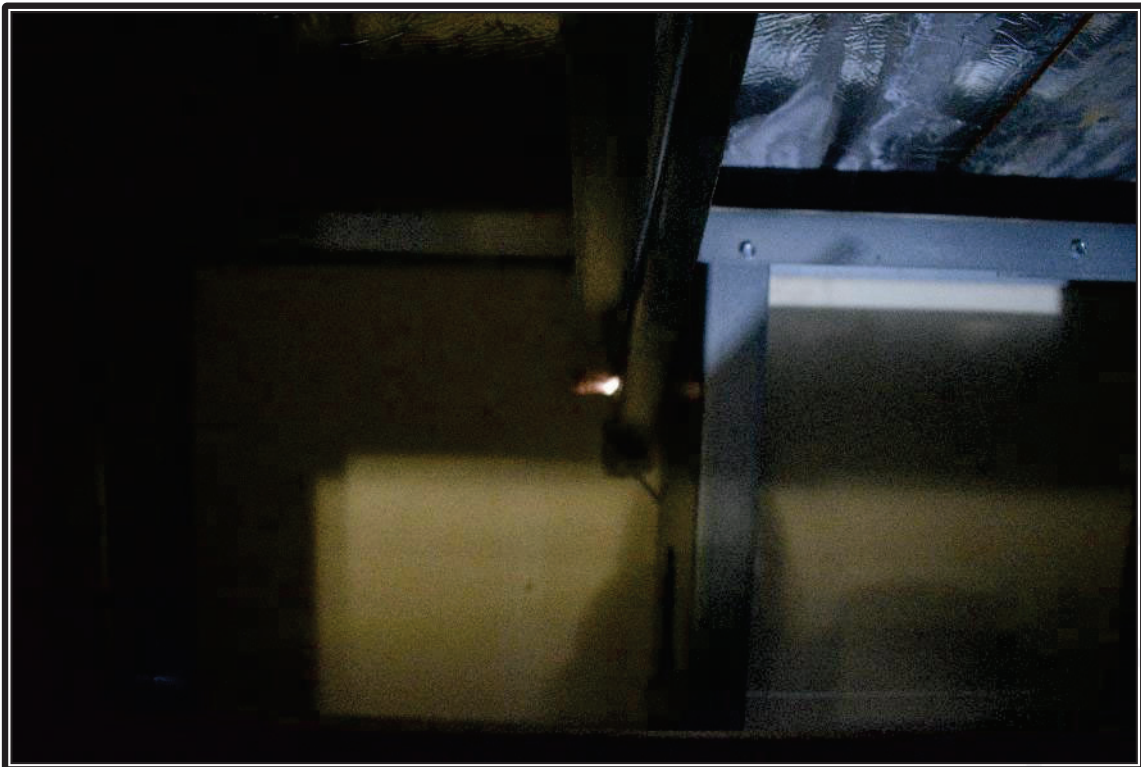
**Photo 23:** Representative view of visible daylight through an unsealed penetration at the exterior wall sheathing.

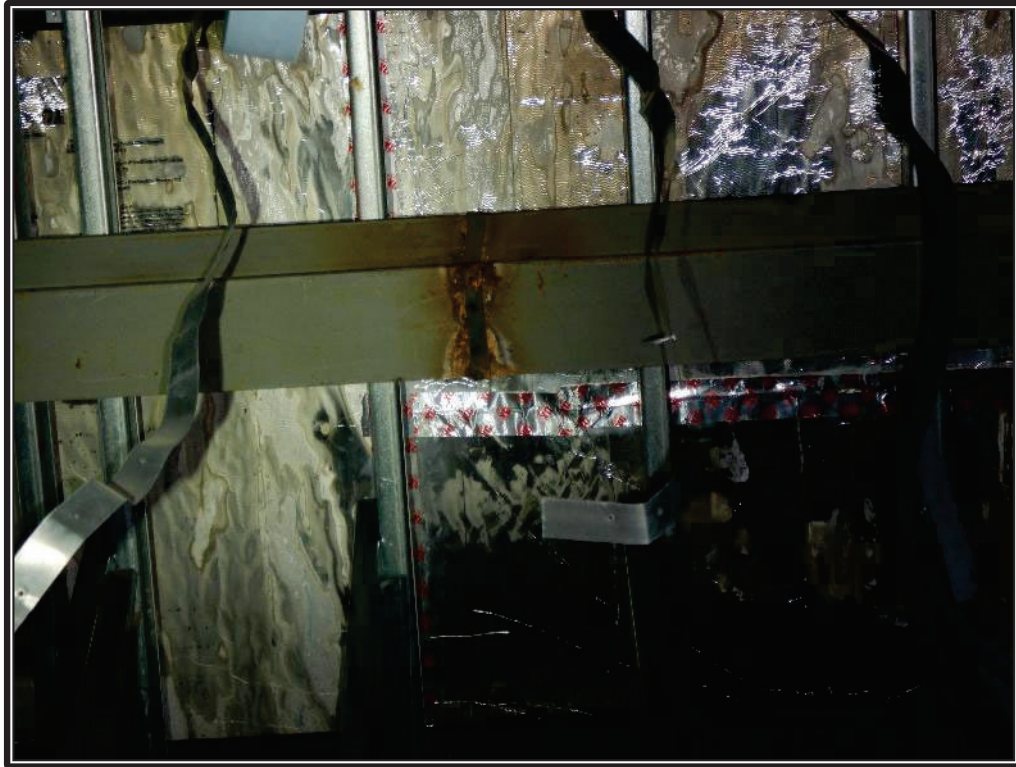
**Photo 24:** Representative view of an apparent uncoated field weld with surface deterioration at a PEMB beam splice.

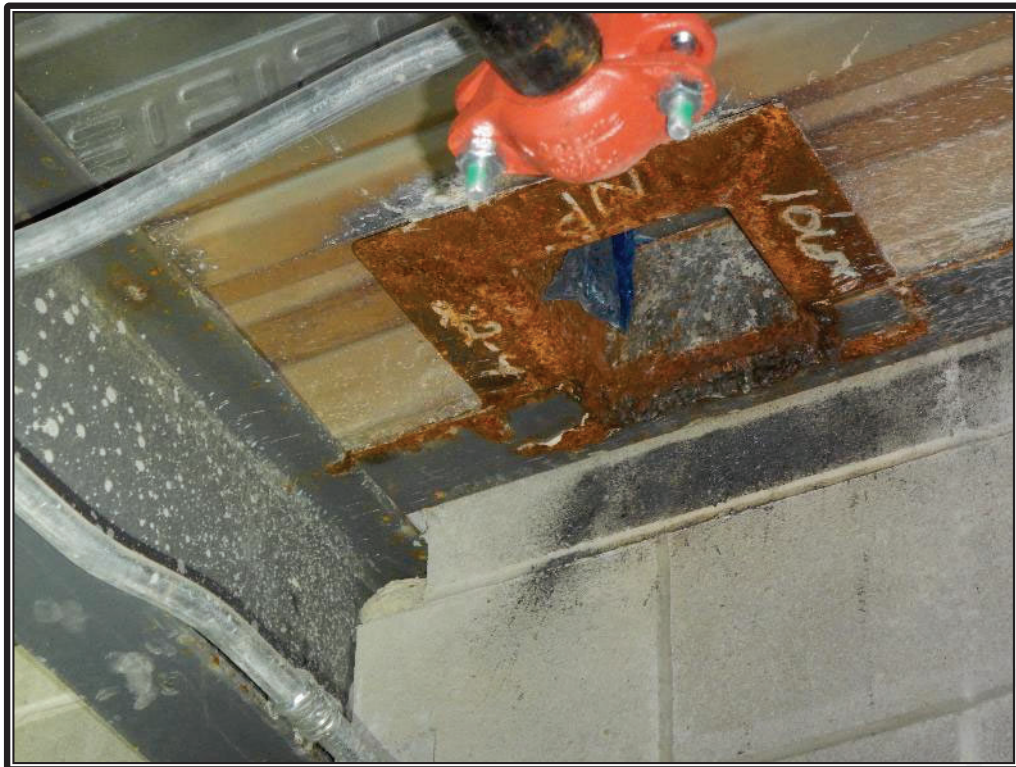
**Photo 25:** Representative view of an apparent uncoated field weld with surface deterioration.

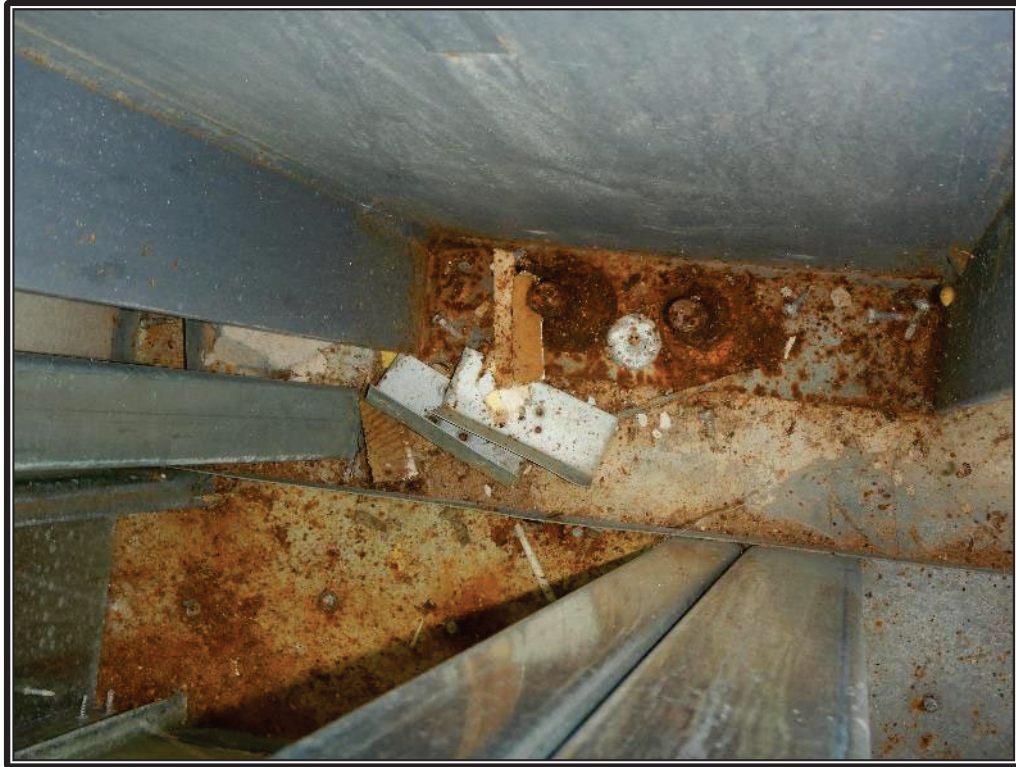
**Photo 26:** Representative view of the bolts and structural steel with surface corrosion.

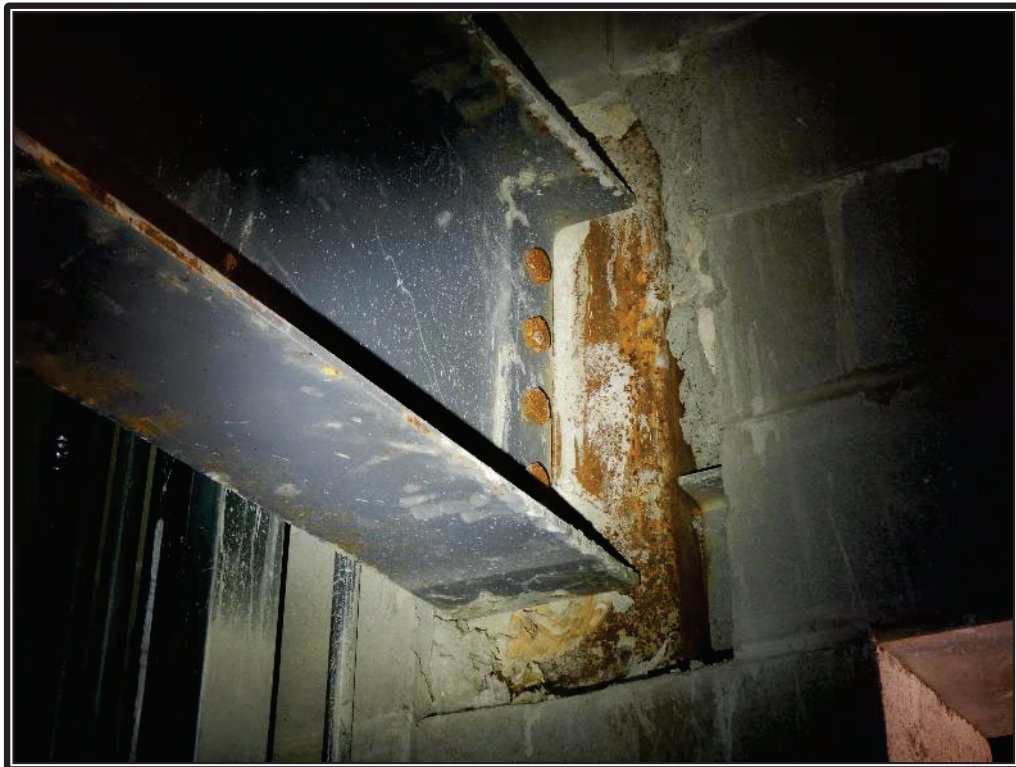
**Photo 27:** Representative view of the bolts and structural steel with surface corrosion.

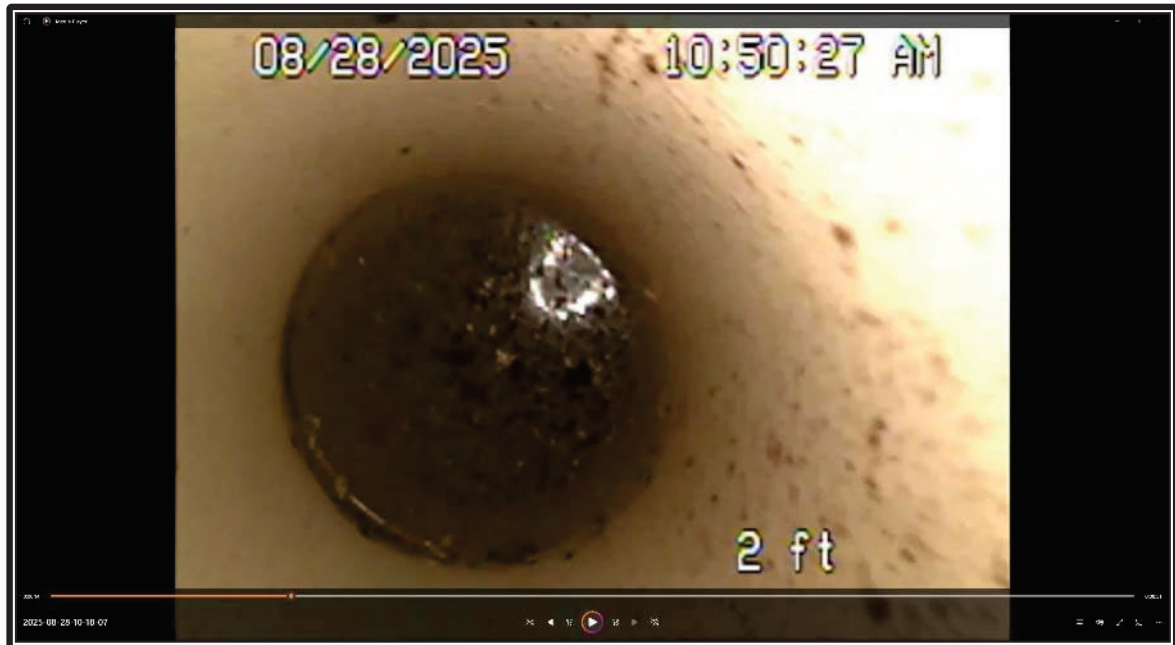
**Photo 28:** Representative view of a water/debris-filled pipe (courtesy of Next Level).

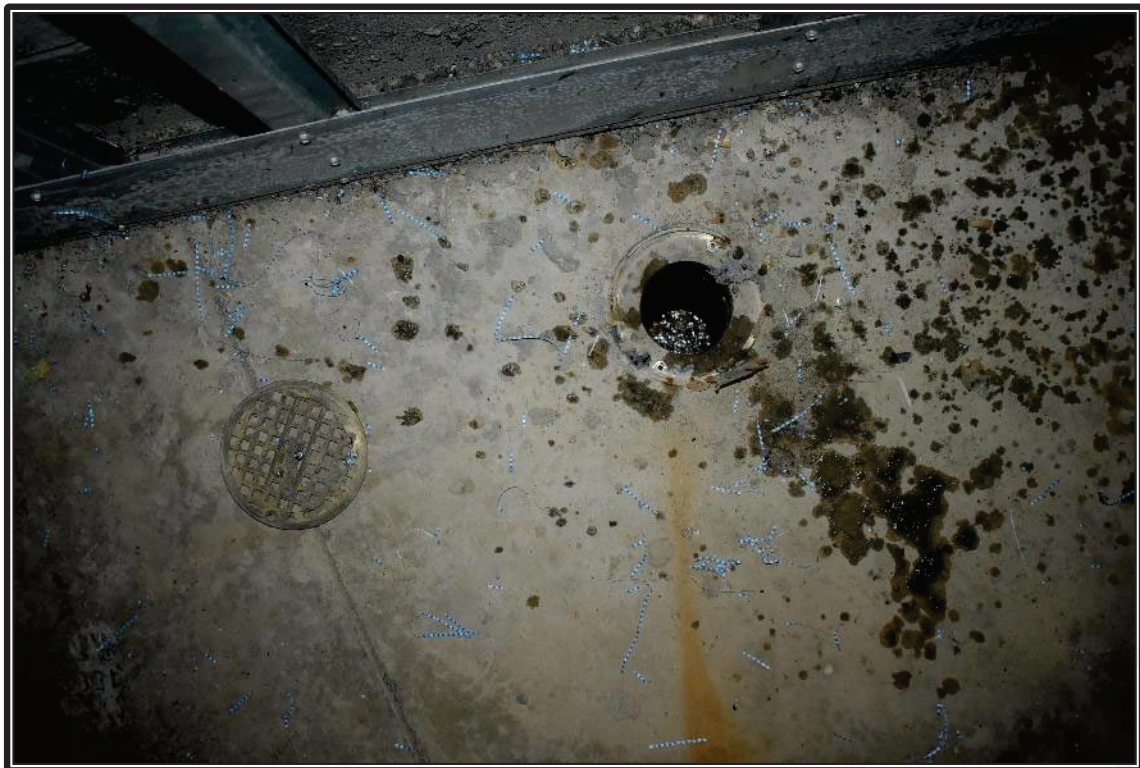
**Photo 29:** Representative view of a pipe filled with a watery sludge.

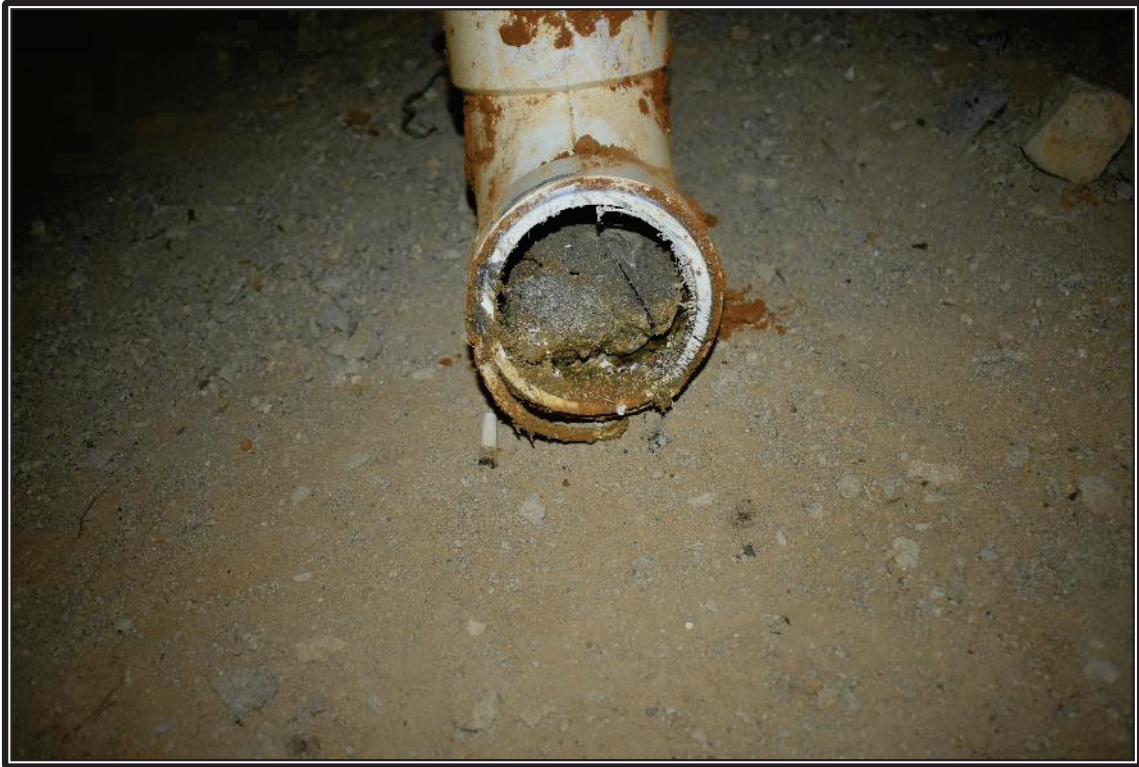
**Photo 30:** View of debris/dirt/stone-filled pipe.

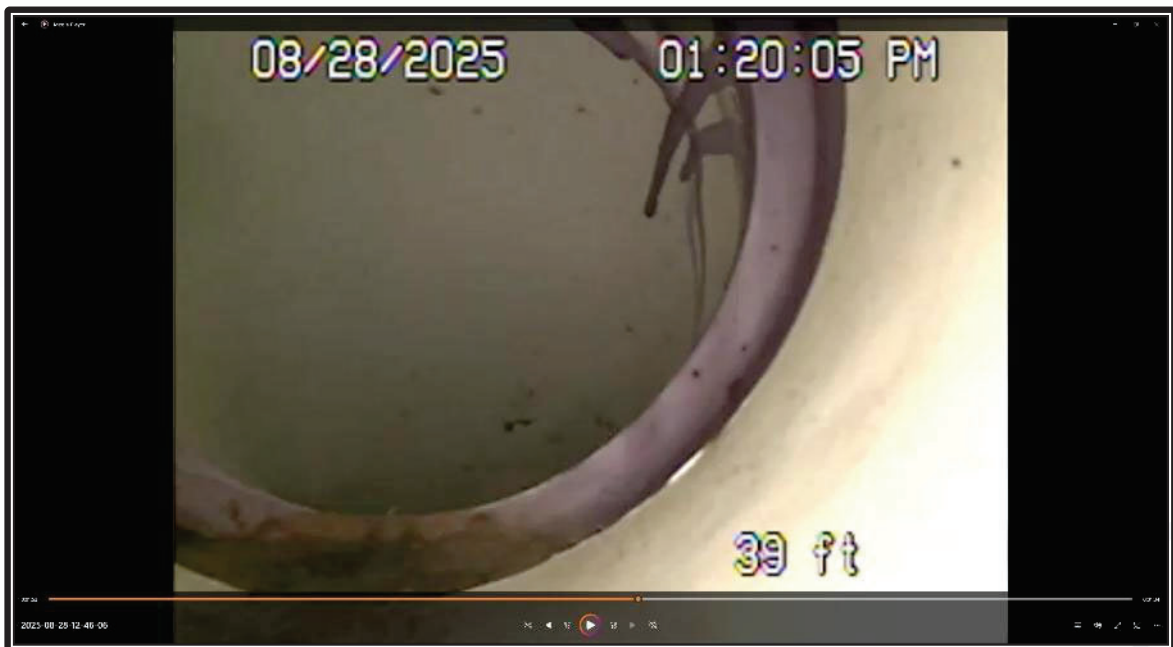
**Photo 31:** Representative view of a partially separated or poorly fit pipe joint (courtesy of Next Level).

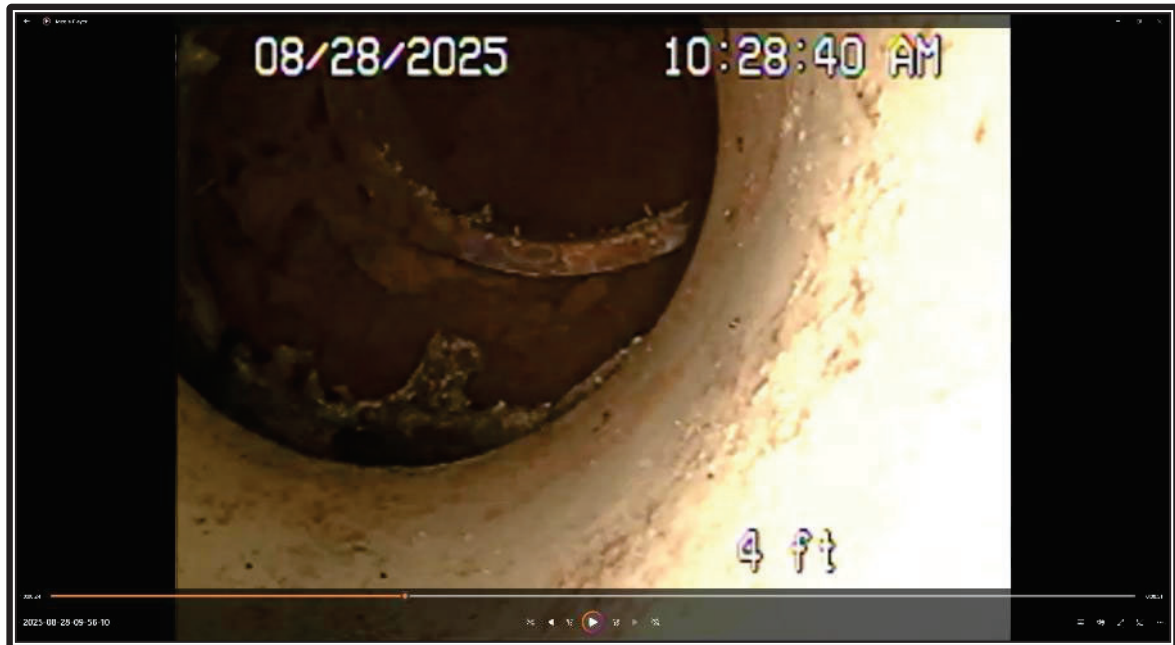
**Photo 32:** Representative view of a separated/cracked/collapsed section of pipe (courtesy of Next Level).

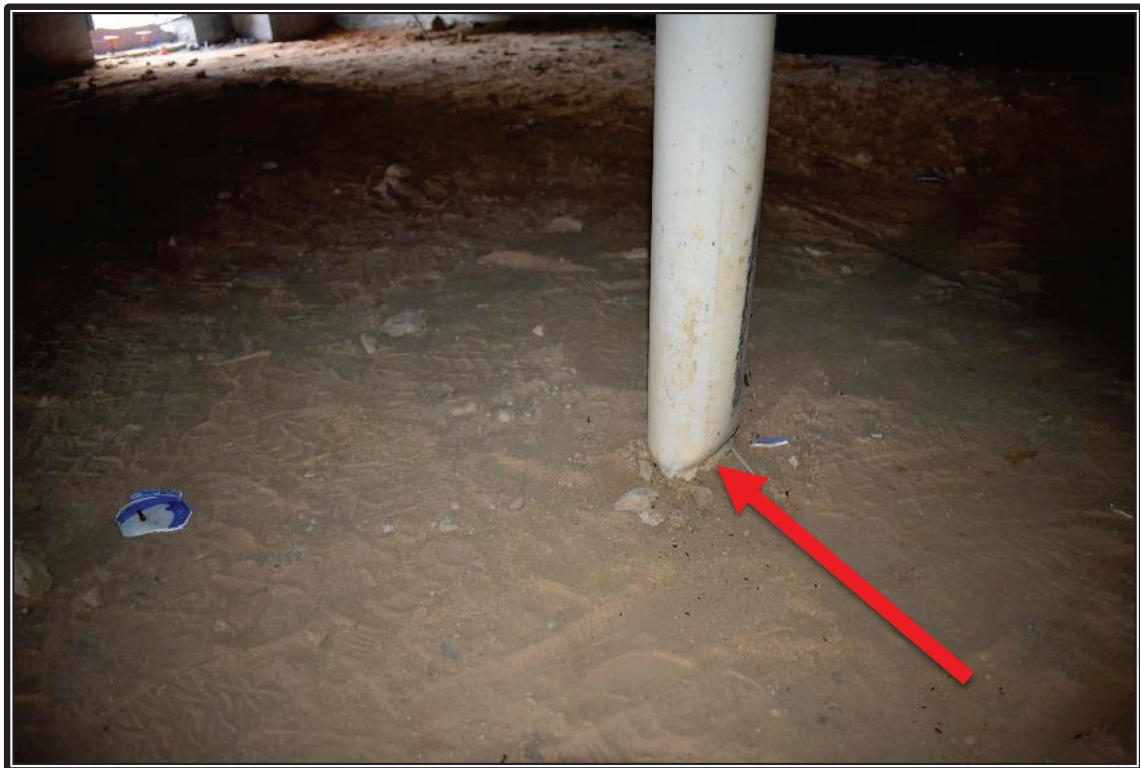
**Photo 33:** Representative view of partially bent over and collapsed pipe stub (arrow).
