## ENGINEERING REPORT

**November 12, 2025**

**RE: Construction Defect Assessment  
City of Fayetteville  
Fayetteville Fire Department New Sub-Station No. 4  
4210 Bragg Boulevard  
Fayetteville, North Carolina 28303  
ABS File Number: 900.25030**

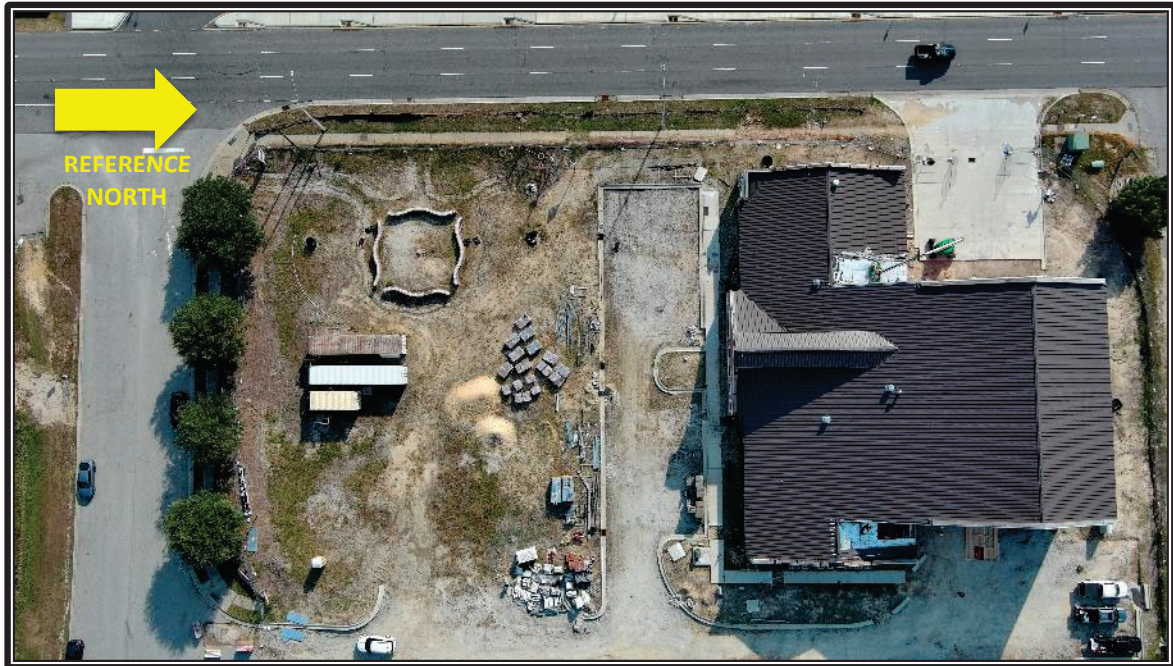
**Photo 1** is an aerial drone view of the site, and **Photo 2** is an aerial drone view of Sub-Station No. 4 (“the building”). **Photo 3** is a drone view of the west (front) elevation of the building. Currently, the construction of the project is incomplete, and ongoing construction efforts have been suspended.

**Photo 1:** Aerial drone view of the site.

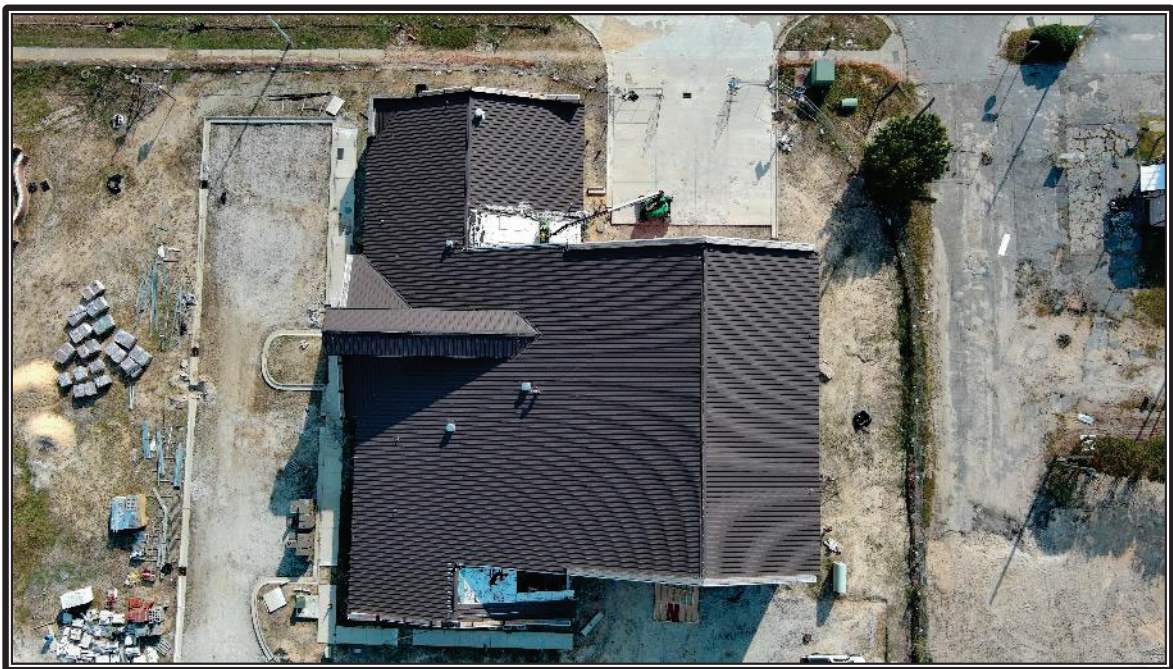
**Photo 2:** Aerial drone view of the building.

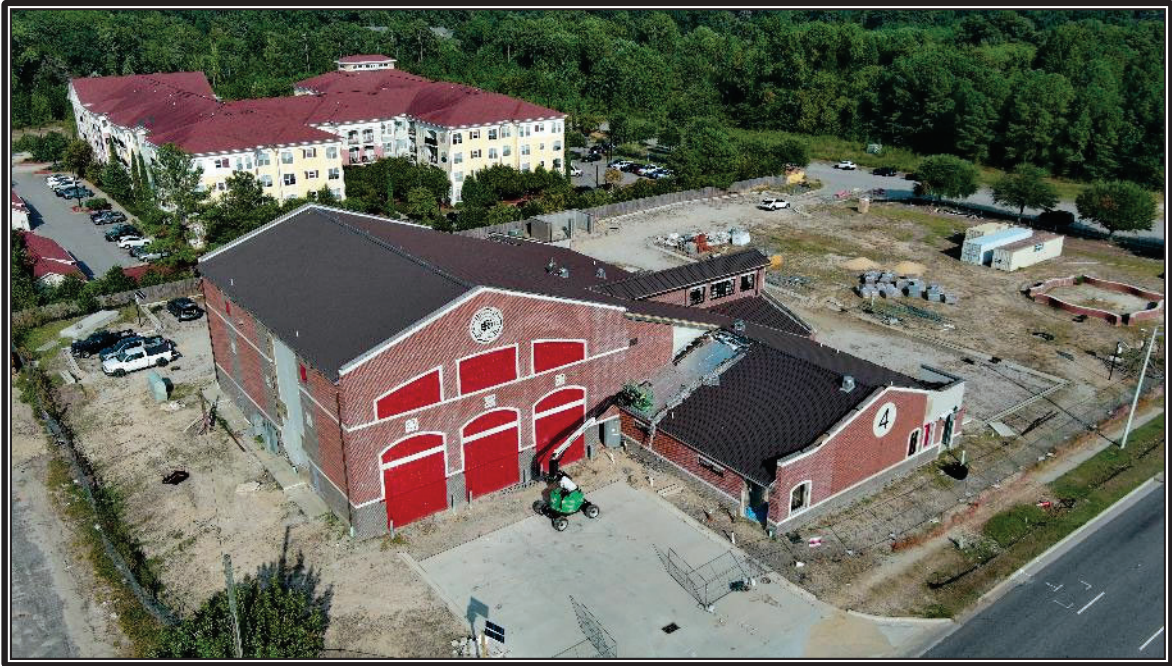
**Photo 3:** Aerial drone view of the west (front) elevation of the building.

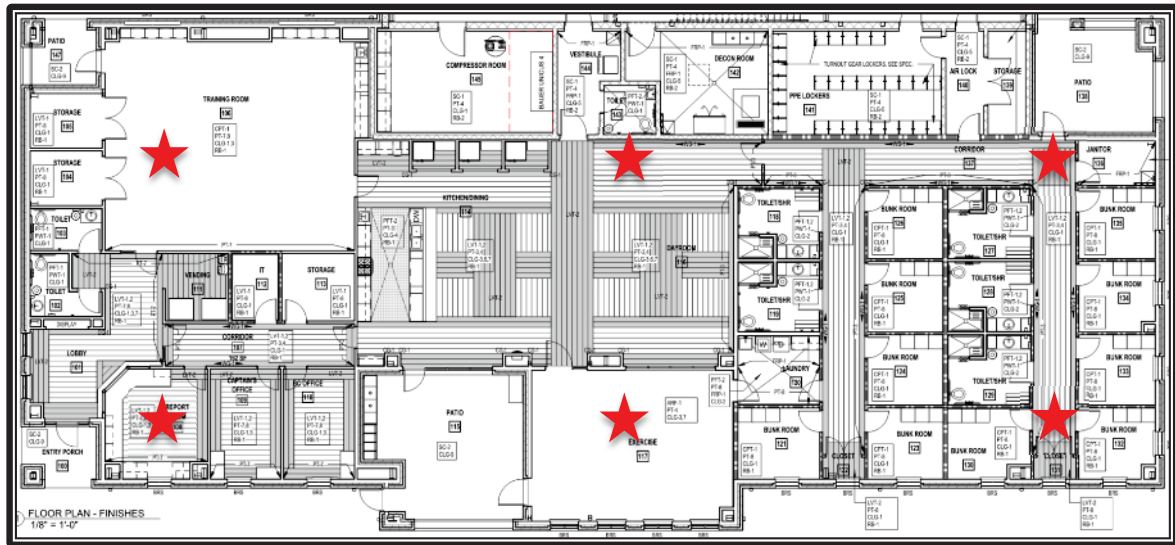
2. At each of the core drilling locations, a 10-mil vapor retarder was observed at the underside of the concrete slab above the stone base.
3. WWF was observed within each of the six (6) cores. Measured from the bottom of the slab core, the cover of the wire at three (3) of the cores measured approximately 1 inch; at the three (3) remaining cores, the cover of the wire measured approximately 1.25 inches, 0.75 inches, and 0.5 inches. The 4-inch diameter concrete cores each intersected one (1) parallel wire, indicating that the spacing of the welded wire fabric exceeded 4 inches. The specified WWF spacing was 6 inches.

**Figure 1:** Partial plan of the building showing the six (6) approximate core drilling locations (stars) (cropped plan courtesy of SCNA).

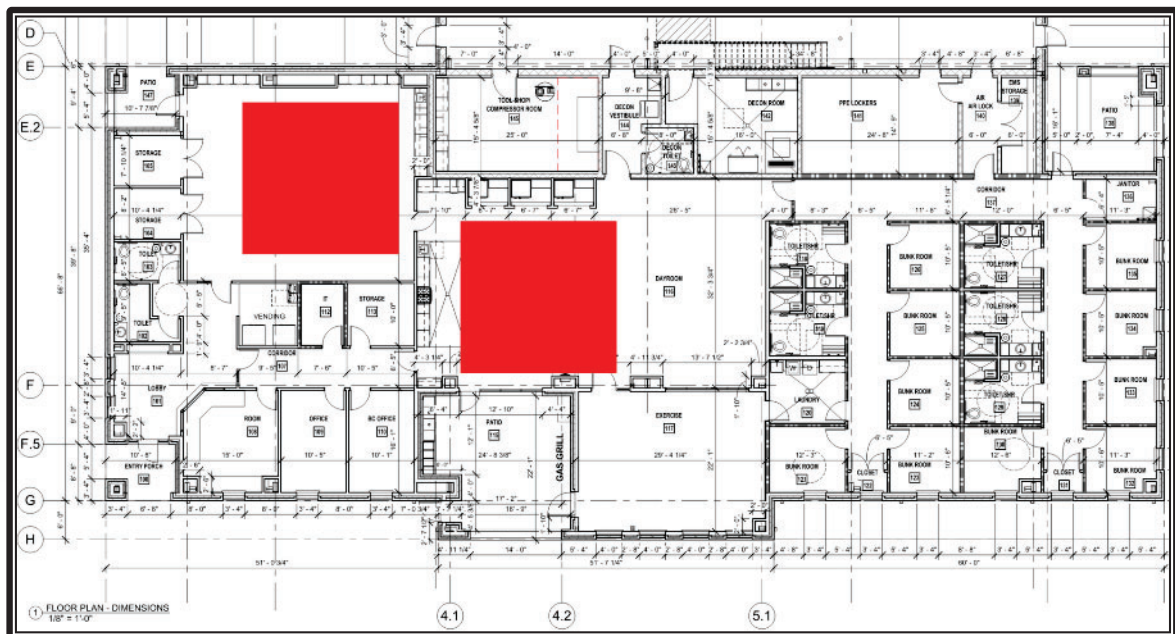
4. At the training room, the maximum elevation difference between any of the 36 measured locations was 0.84 inches.
5. At the dayroom, the maximum elevation difference between any of the 36 measured locations was 0.96 inches.
6. At the mezzanine, the maximum elevation difference between any of the 20 measured locations was 1.08 inches.
7. Significant irregularities in the concrete slab surfaces at any of the three (3) reviewed areas were not visually observed.

**Figure 2:** Partial plan of the building showing the approximate location of the two (2) levelness and flatness testing areas at the living area slab-on-ground (shaded) (cropped plan courtesy of SCNA).

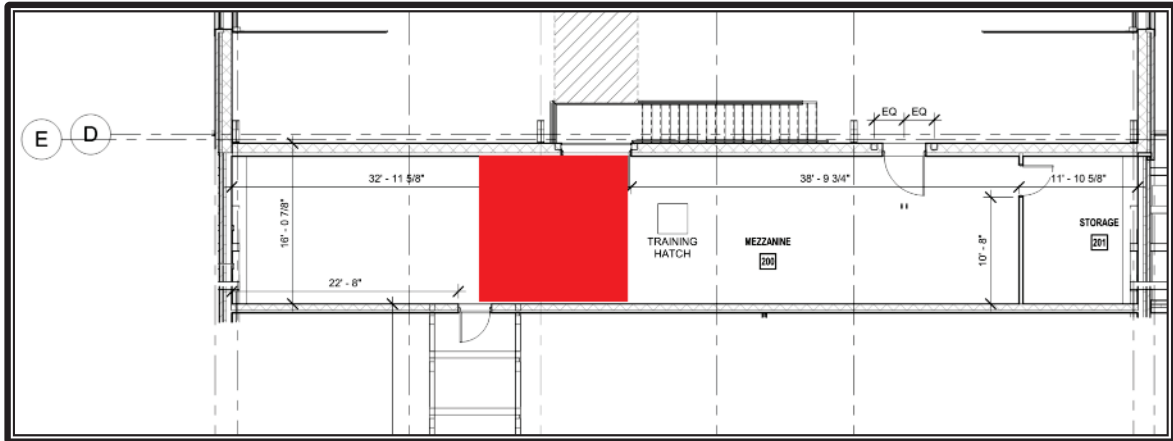
**Figure 3:** Partial plan of the building showing the approximate location of the one (1) levelness and flatness testing area at the mezzanine elevated slab (shaded) (cropped plan courtesy of SCNA).

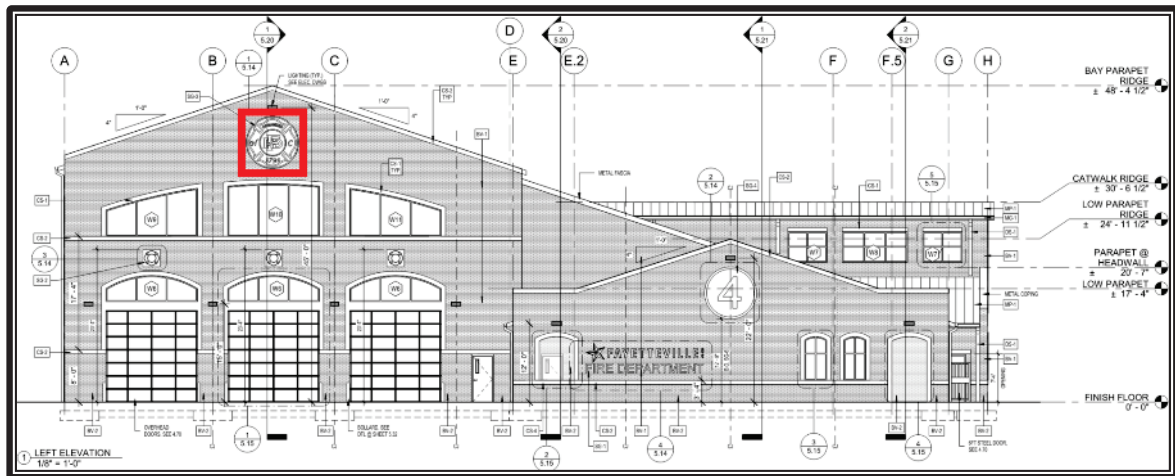
Test Area 1 was located at the large medallion on the west elevation of the apparatus bay above the bay door openings (**Figure 10**). In total, two (2) large medallions were installed at the exterior of the building. Investigation at Test Area 1 served as a representative sample of the construction

**Figure 10:** West exterior wall elevation showing the approximate location of Test Area 1 (outlined) (cropped plan courtesy of SCNA).

If the anchoring of the sector sections depicted on the shop drawings was used for installation of the ring sections at Test Area 1, missing anchors were identified. Due to the limited access and visibility, all anchors could not be identified; however, ABS was able to confirm that no anchors were installed along the bottom and outer edge of the lower ring section. The equivalent sector section from the shop drawings requires three anchors along this edge. It is ABS' opinion that the anchoring of at least one (1) section of the large cast stone medallions is not in compliance with the exterior cast stone shop drawings.

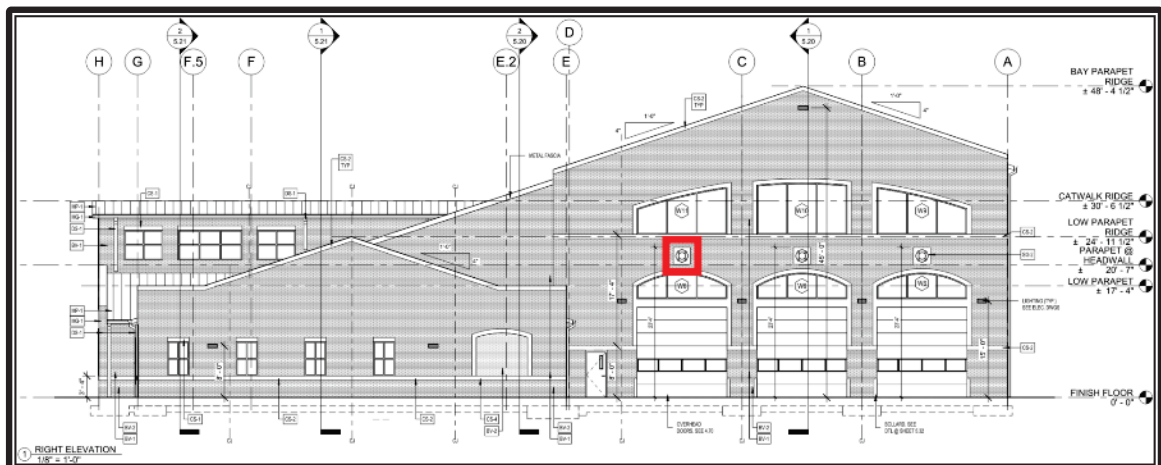
Test Area 2 was located at the southernmost small medallion on the east elevation of the apparatus bay (Figure 11). In total, nine (9) small medallions were installed at the exterior of the building. Investigation at Test Area 2 served as a representative sample of the construction of the small medallions. ABS removed five (5) full or partial brick veneer units located around the top, bottom, or right edge of the small cast stone medallion.

**Figure 11:** East exterior wall elevation showing the approximate location of Test Area 2 (outlined) (cropped plan courtesy of SCNA).

38. The cast stone medallion at Test Area 2 was comprised of a single rectangular section of cast stone.

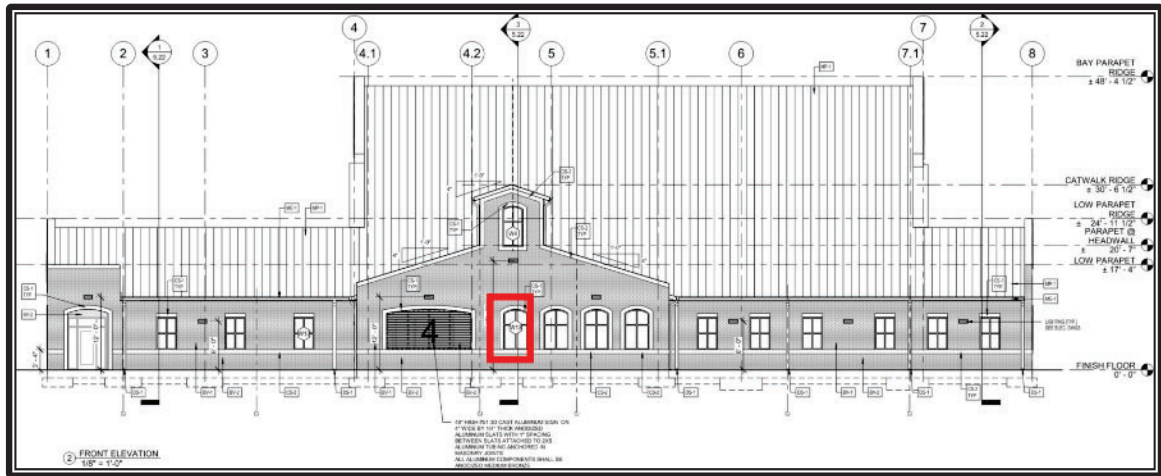
Test Area 3 was located around the window opening at the south elevation of the living area (**Figure 12**). The test area included cast stone accents at the head and jambs of the window opening as well as the water table along the elevation of the brick veneer wall. ABS removed three (3) full brick veneer units located around the cast stone accents.

**Figure 12:** South exterior wall elevation showing the approximate location of Test Area 3 (outlined) (cropped plan courtesy of SCNA).

42. The cast stone accents at the jamb of the window were comprised of multiple sections of cast stone.
43. At the joint between sections of cast stone along the jamb of the window opening, an anchor was observed. The depth of the anchor flange into the cast stone could not be determined.
44. At the joint between the cast stone at the top of the jamb and the head of the window opening, no anchor was observed.
45. At the top edge of the cast stone along the head of the window, masonry wall ties were observed at each of the intersecting metal studs (**Photo 9**).
46. At the cast stone water table, masonry wall ties were observed along the top and bottom of the stone at each of the intersecting metal studs.

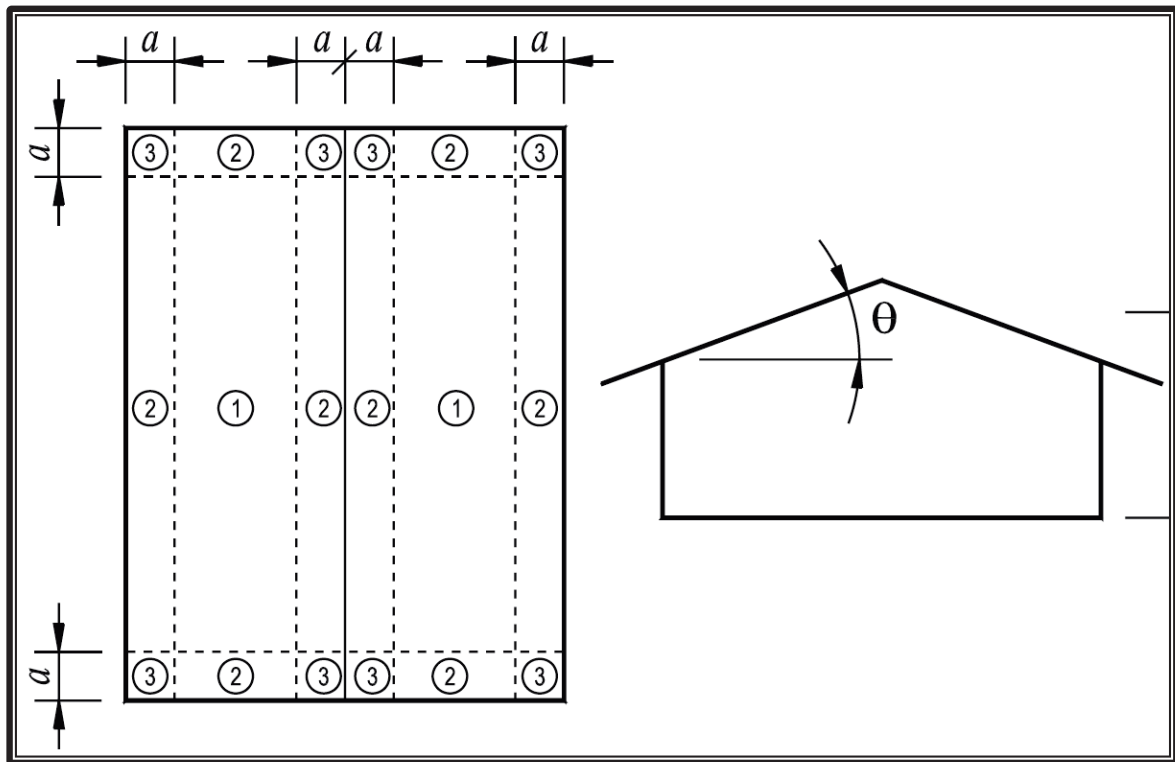
For a view of the zones referenced in the plans (Sheet 3.00), see the diagram from ASCE 7-10 (**Figure 13**).

**Figure 13:** Wind pressure zones for gable roofs with a slope between 7° and 27° (courtesy of ASCE 7-10).
